Figure 1: Land Use

City of Rensselaer
 North Broadway Corridor Study
 Existing Conditions

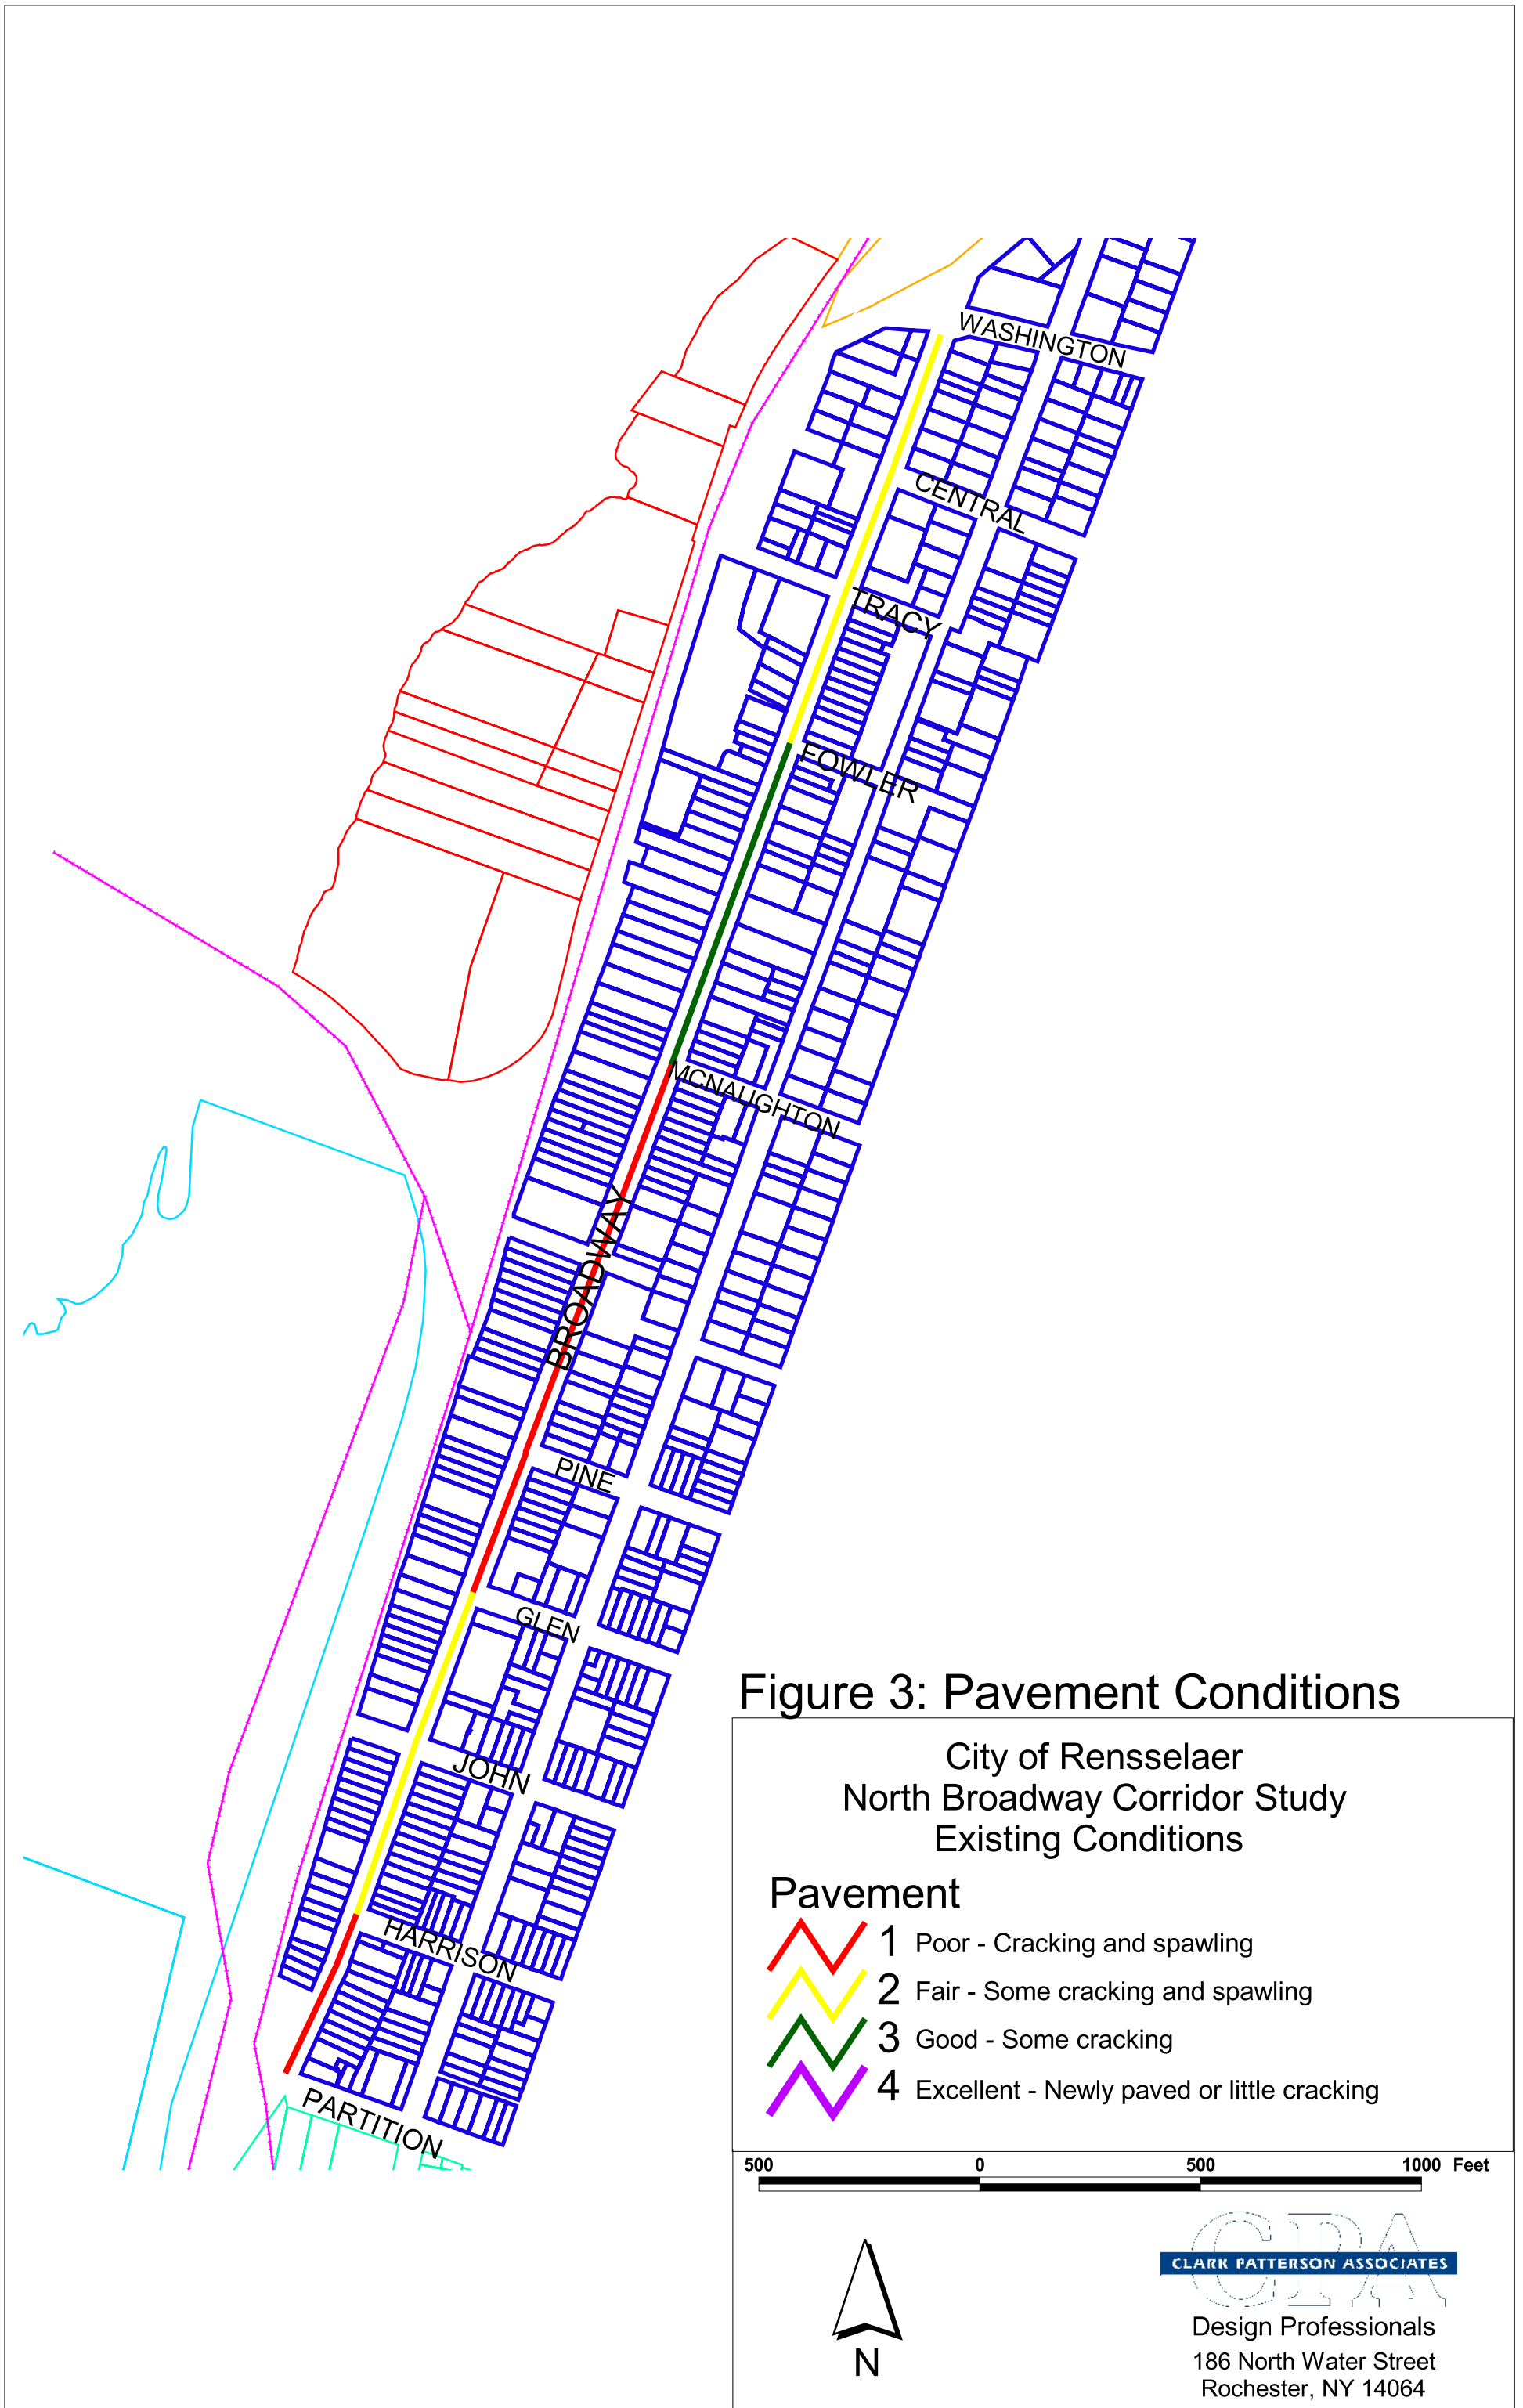
Figure 3: Pavement Conditions

1 Poor - Cracking and spawling
-

2 Fair - Some cracking and spawling
-

3 Good - Some cracking
-

4 Excellent - Newly paved or little cracking

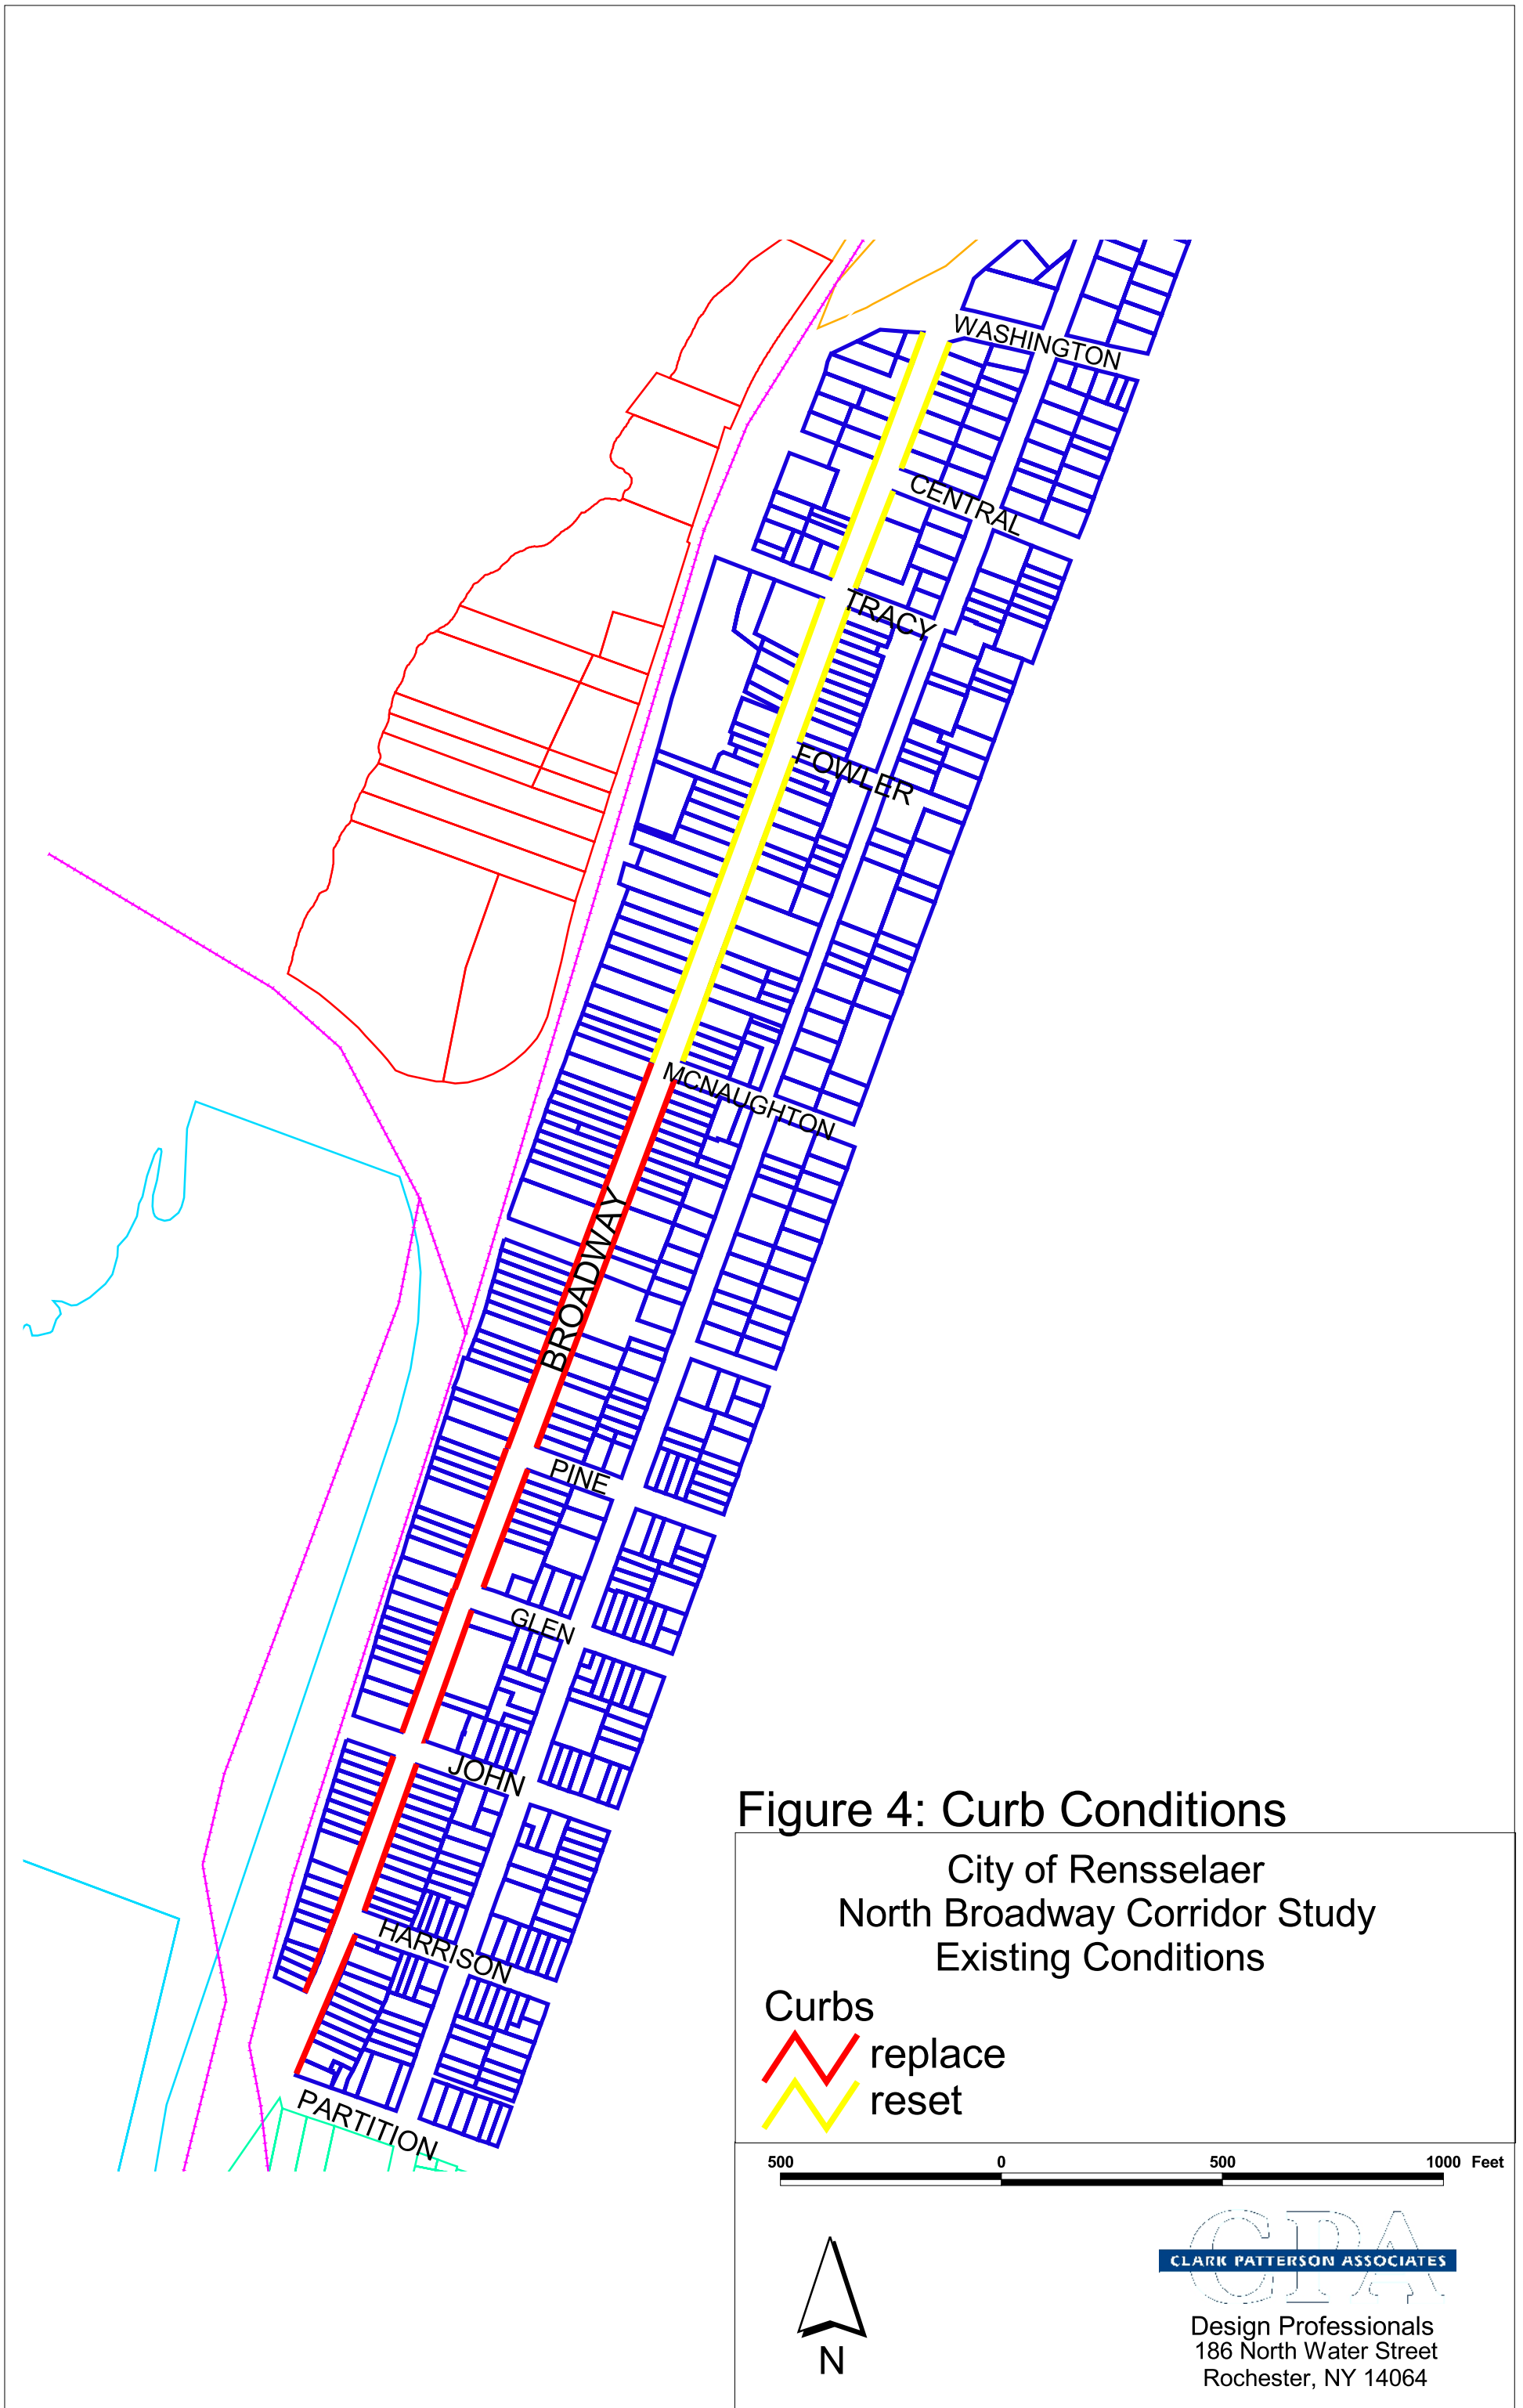
Figure 4: Curb Conditions

replace
 -

reset

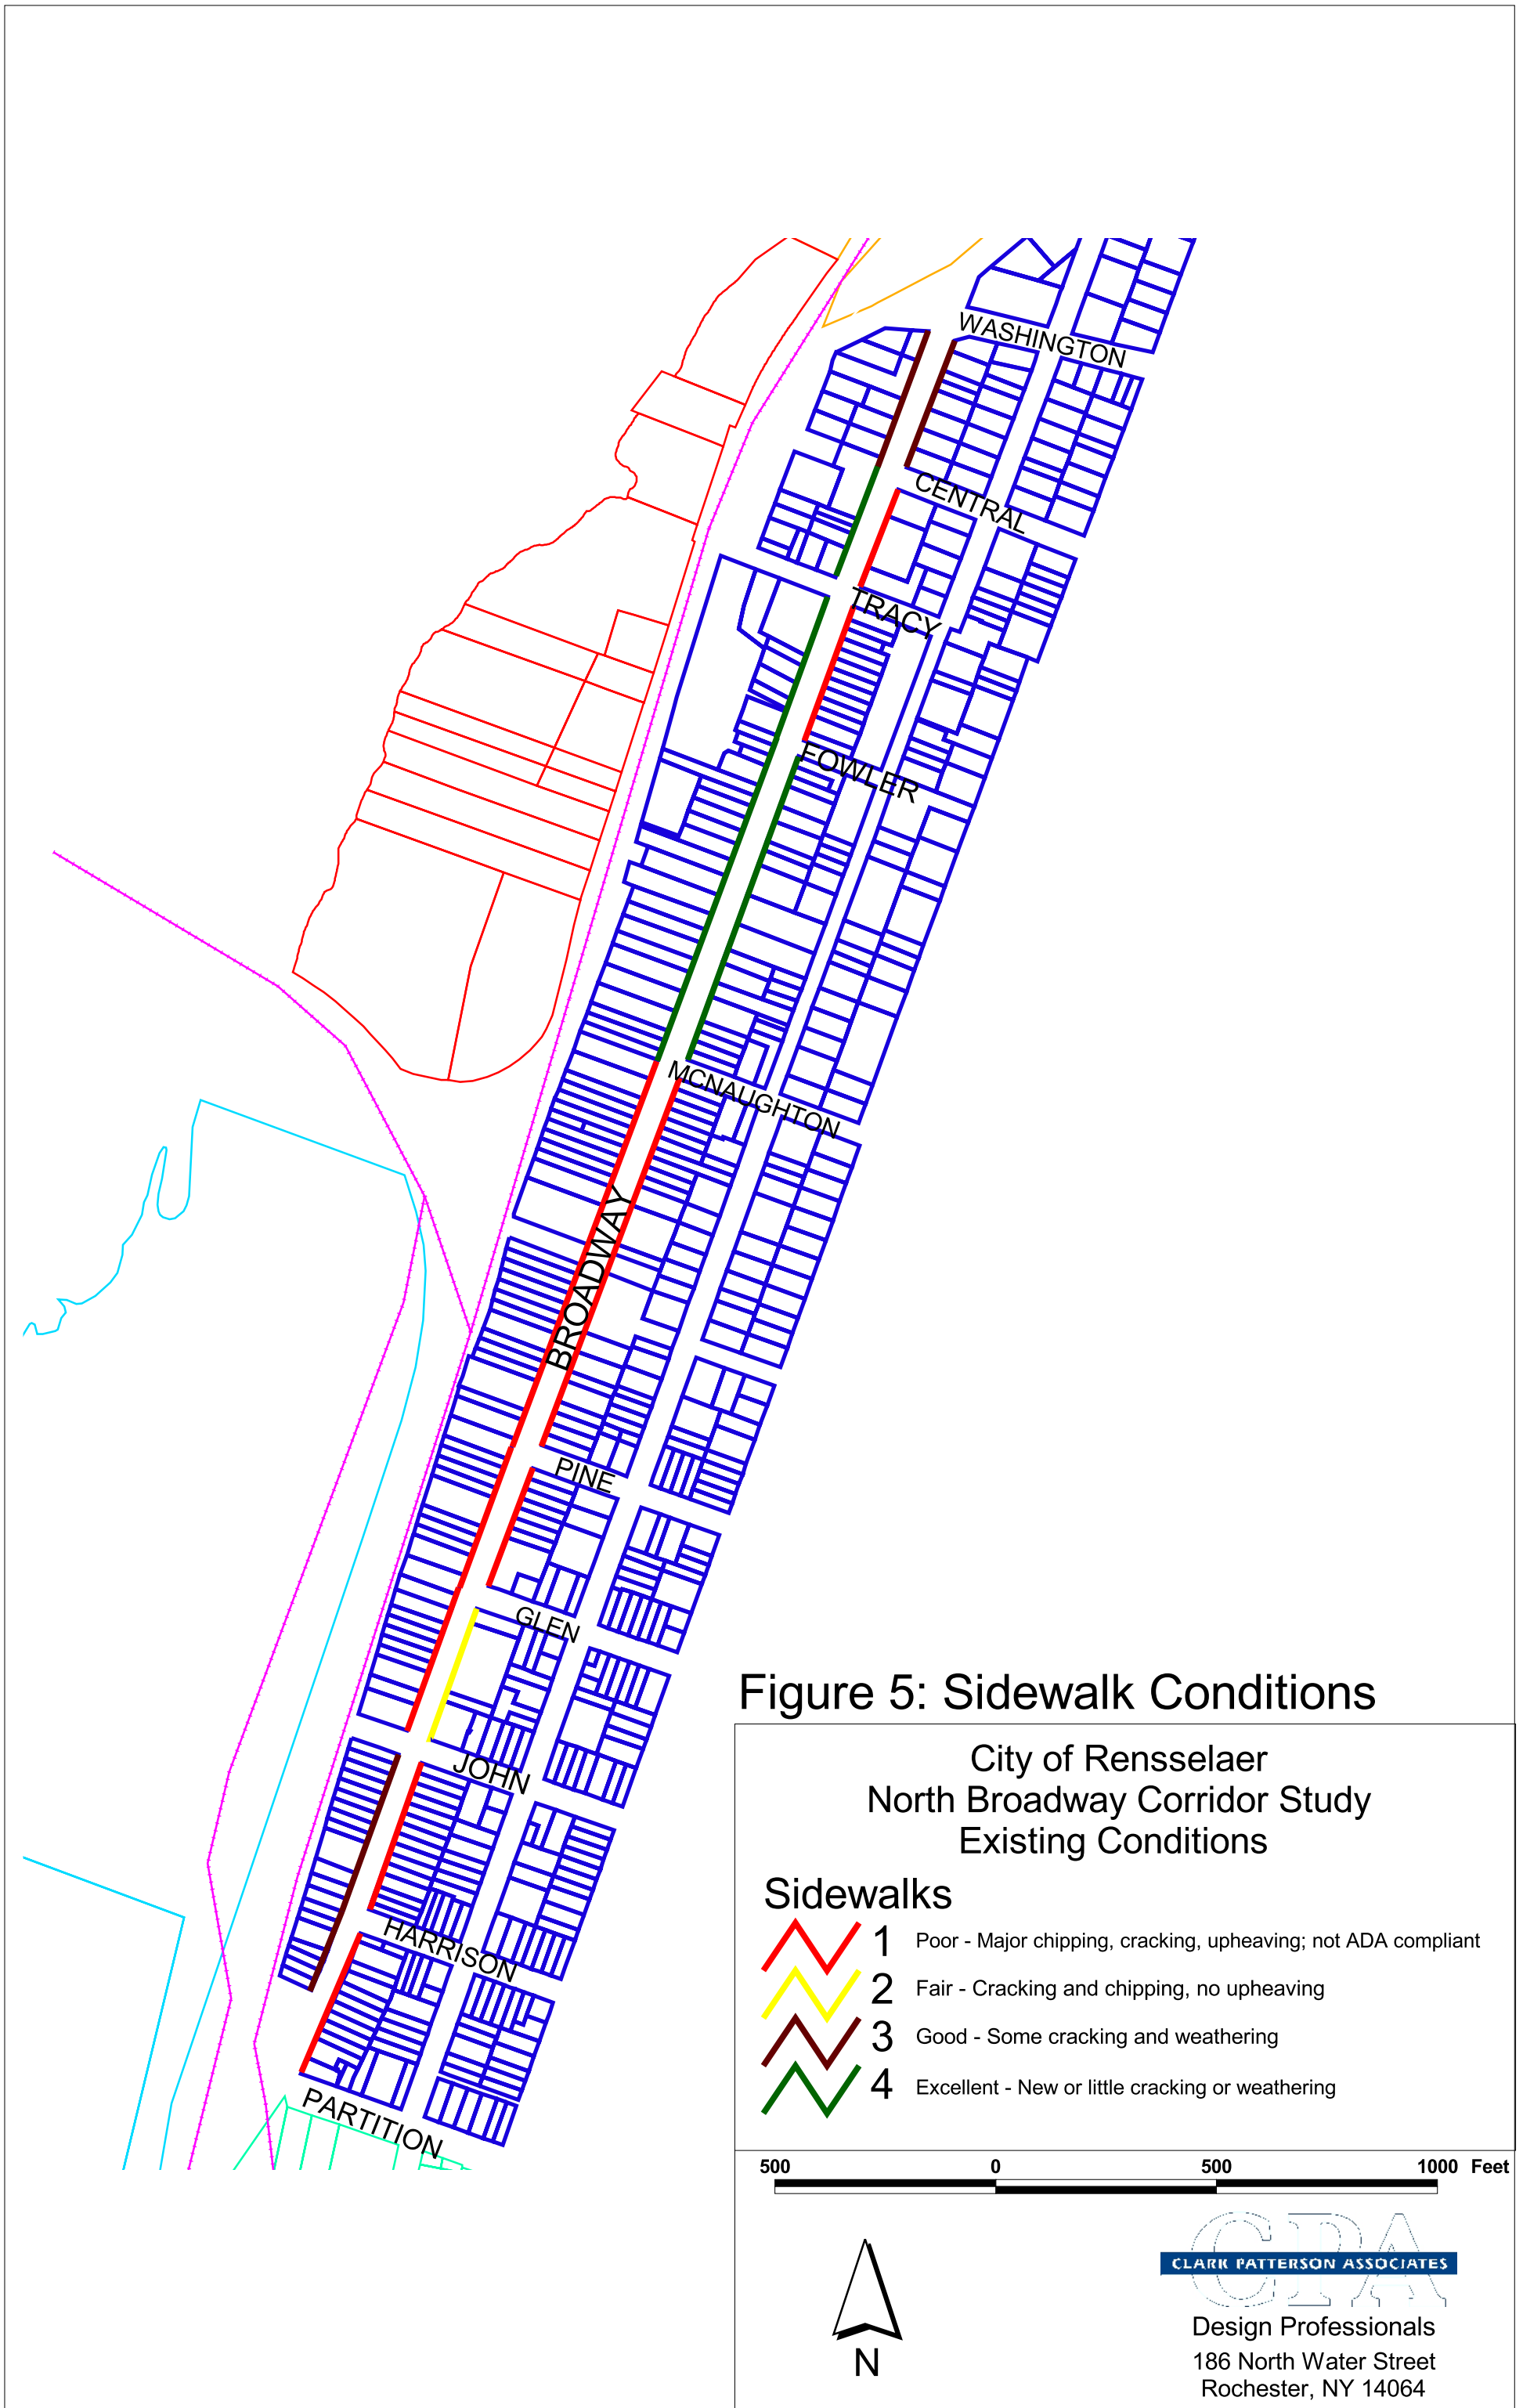
Figure 5: Sidewalk Conditions

1 Poor - Major chipping, cracking, upheaving; not ADA compliant
-

2 Fair - Cracking and chipping, no upheaving
-

3 Good - Some cracking and weathering
-

4 Excellent - New or little cracking or weathering

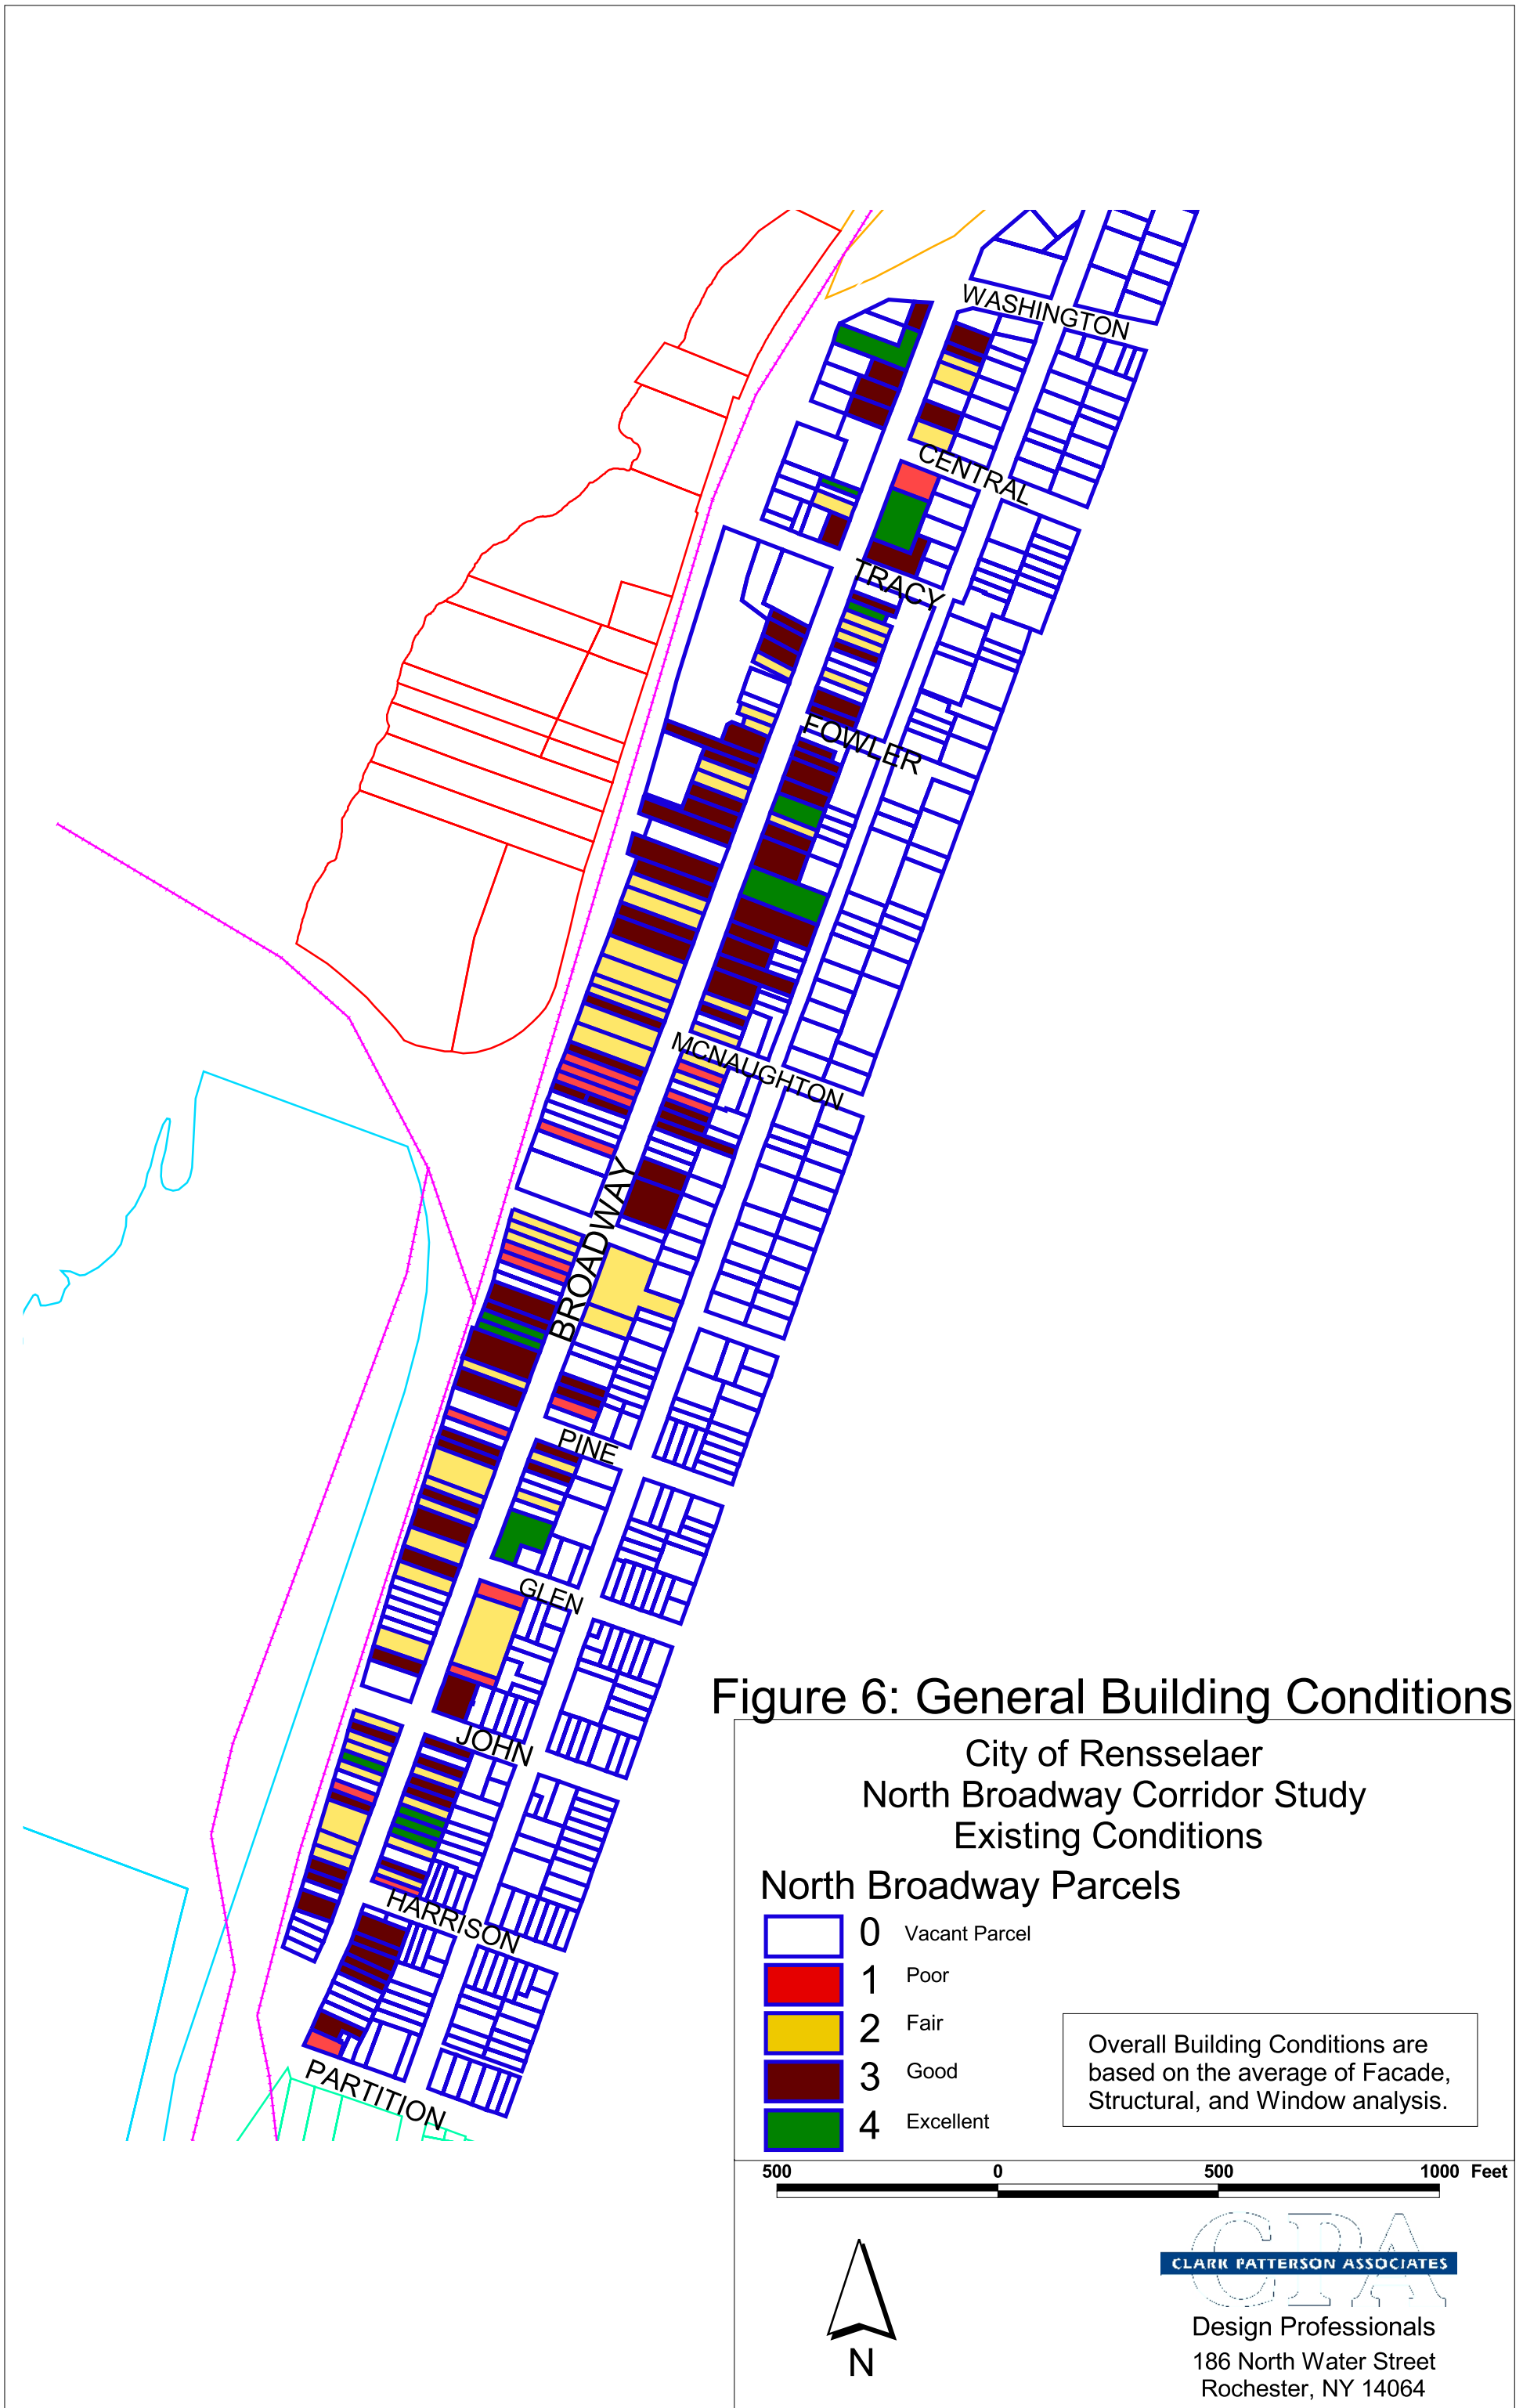
Figure 6: General Building Conditions

Overall Building Conditions are based on the average of Facade, Structural, and Window analysis.

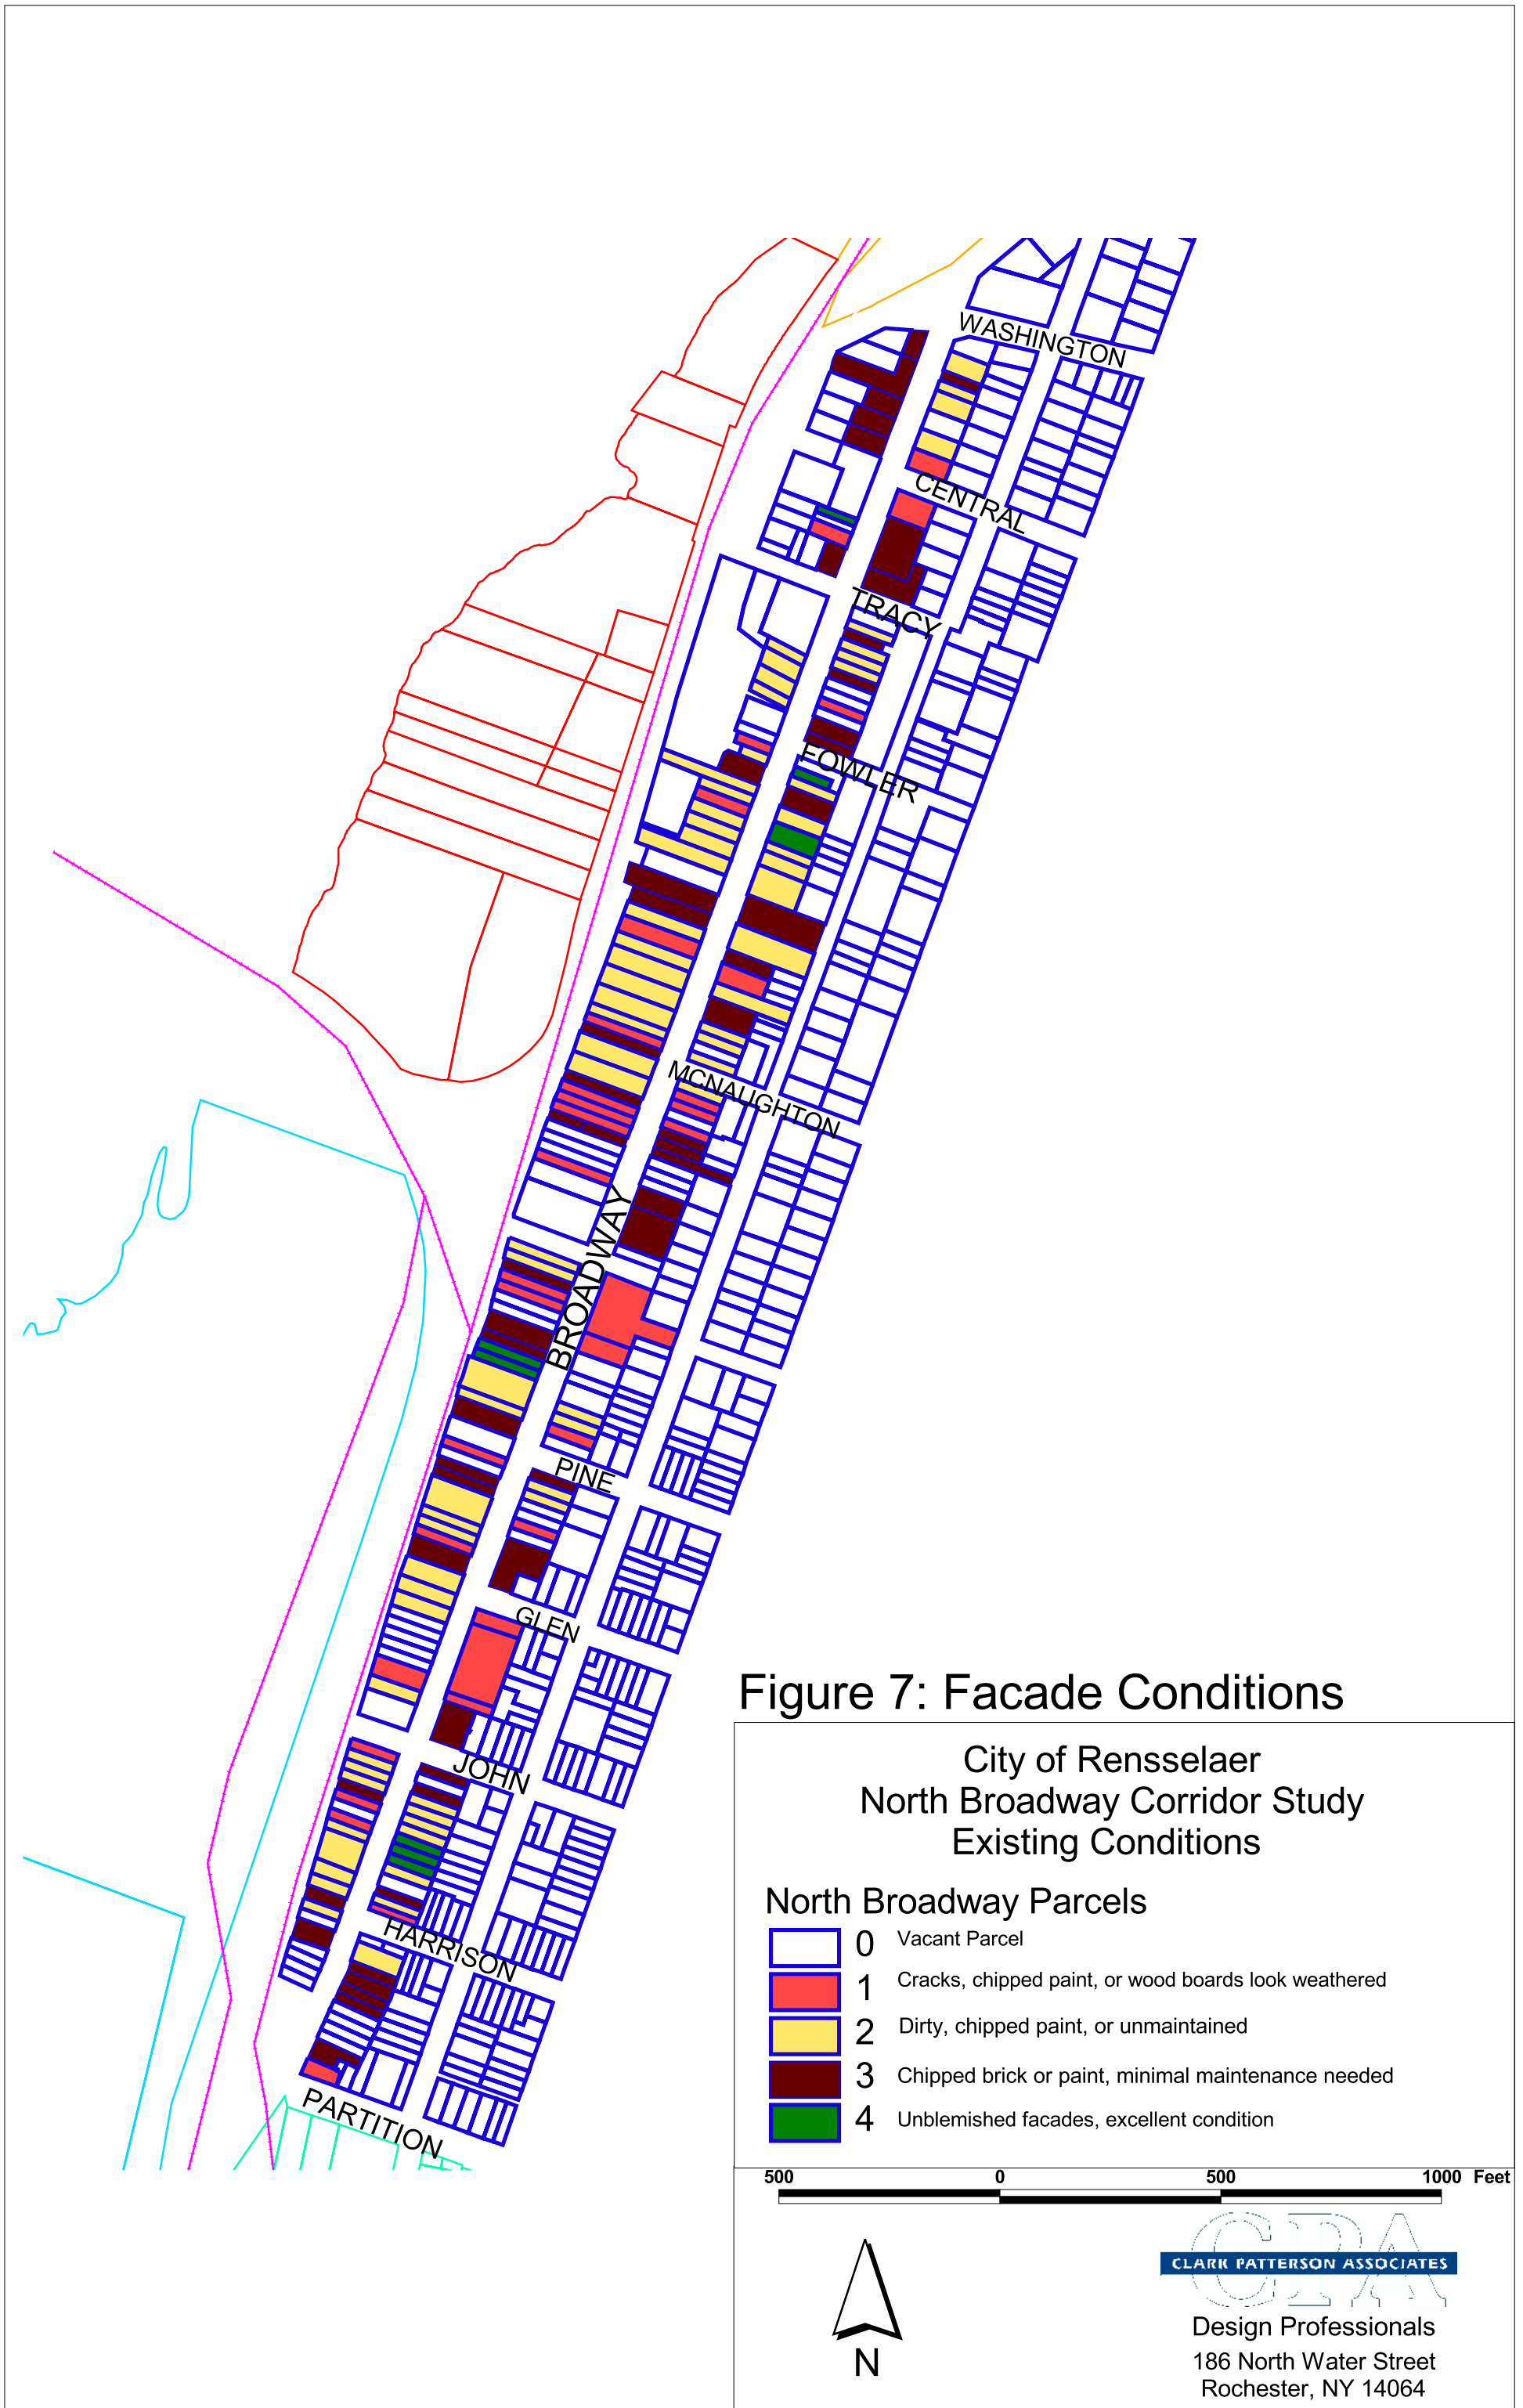
Figure 7: Facade Conditions

- 0 Vacant Parcel
- 1 Cracks, chipped paint, or wood boards look weathered
- 2 Dirty, chipped paint, or unmaintained
- 3 Chipped brick or paint, minimal maintenance needed
- 4 Unblemished facades, excellent condition

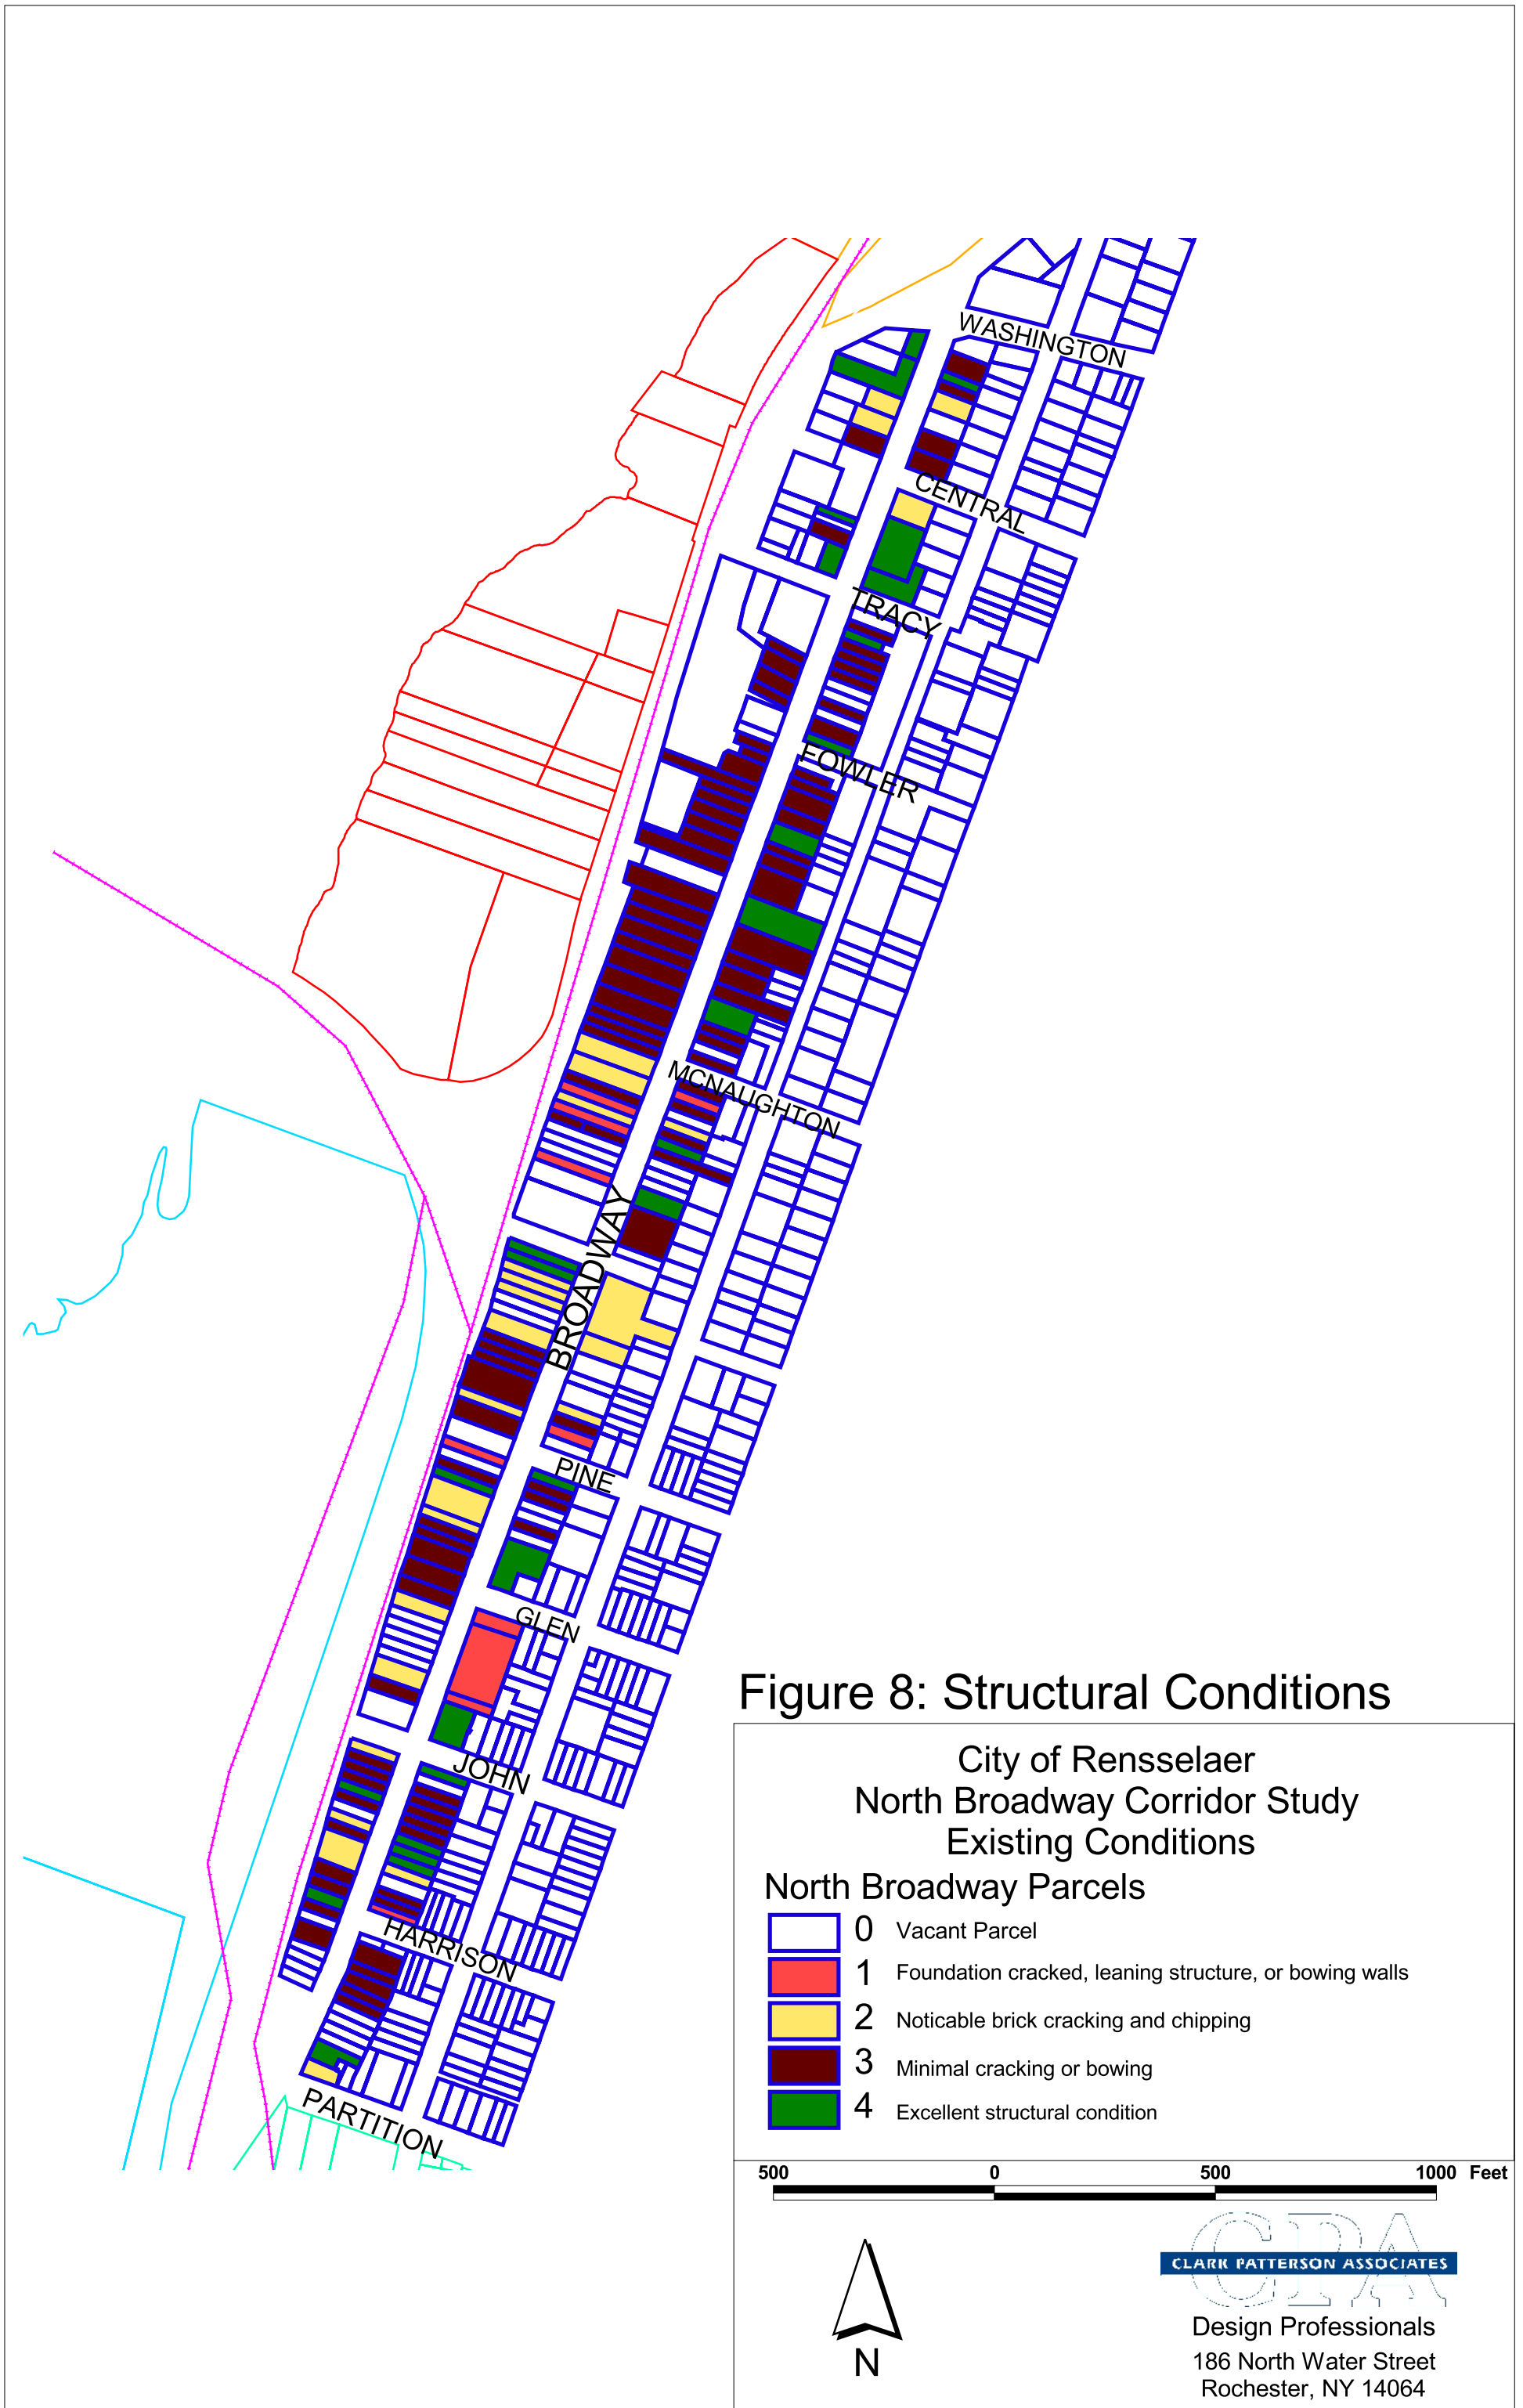
Figure 8: Structural Conditions

- 0 Vacant Parcel
- 1 Foundation cracked, leaning structure, or bowing walls
- 2 Noticable brick cracking and chipping
- 3 Minimal cracking or bowing
- 4 Excellent structural condition
