City of Rensselaer
 North Broadway Corridor Study
 Existing Conditions

Figure 3: Pavement Conditions

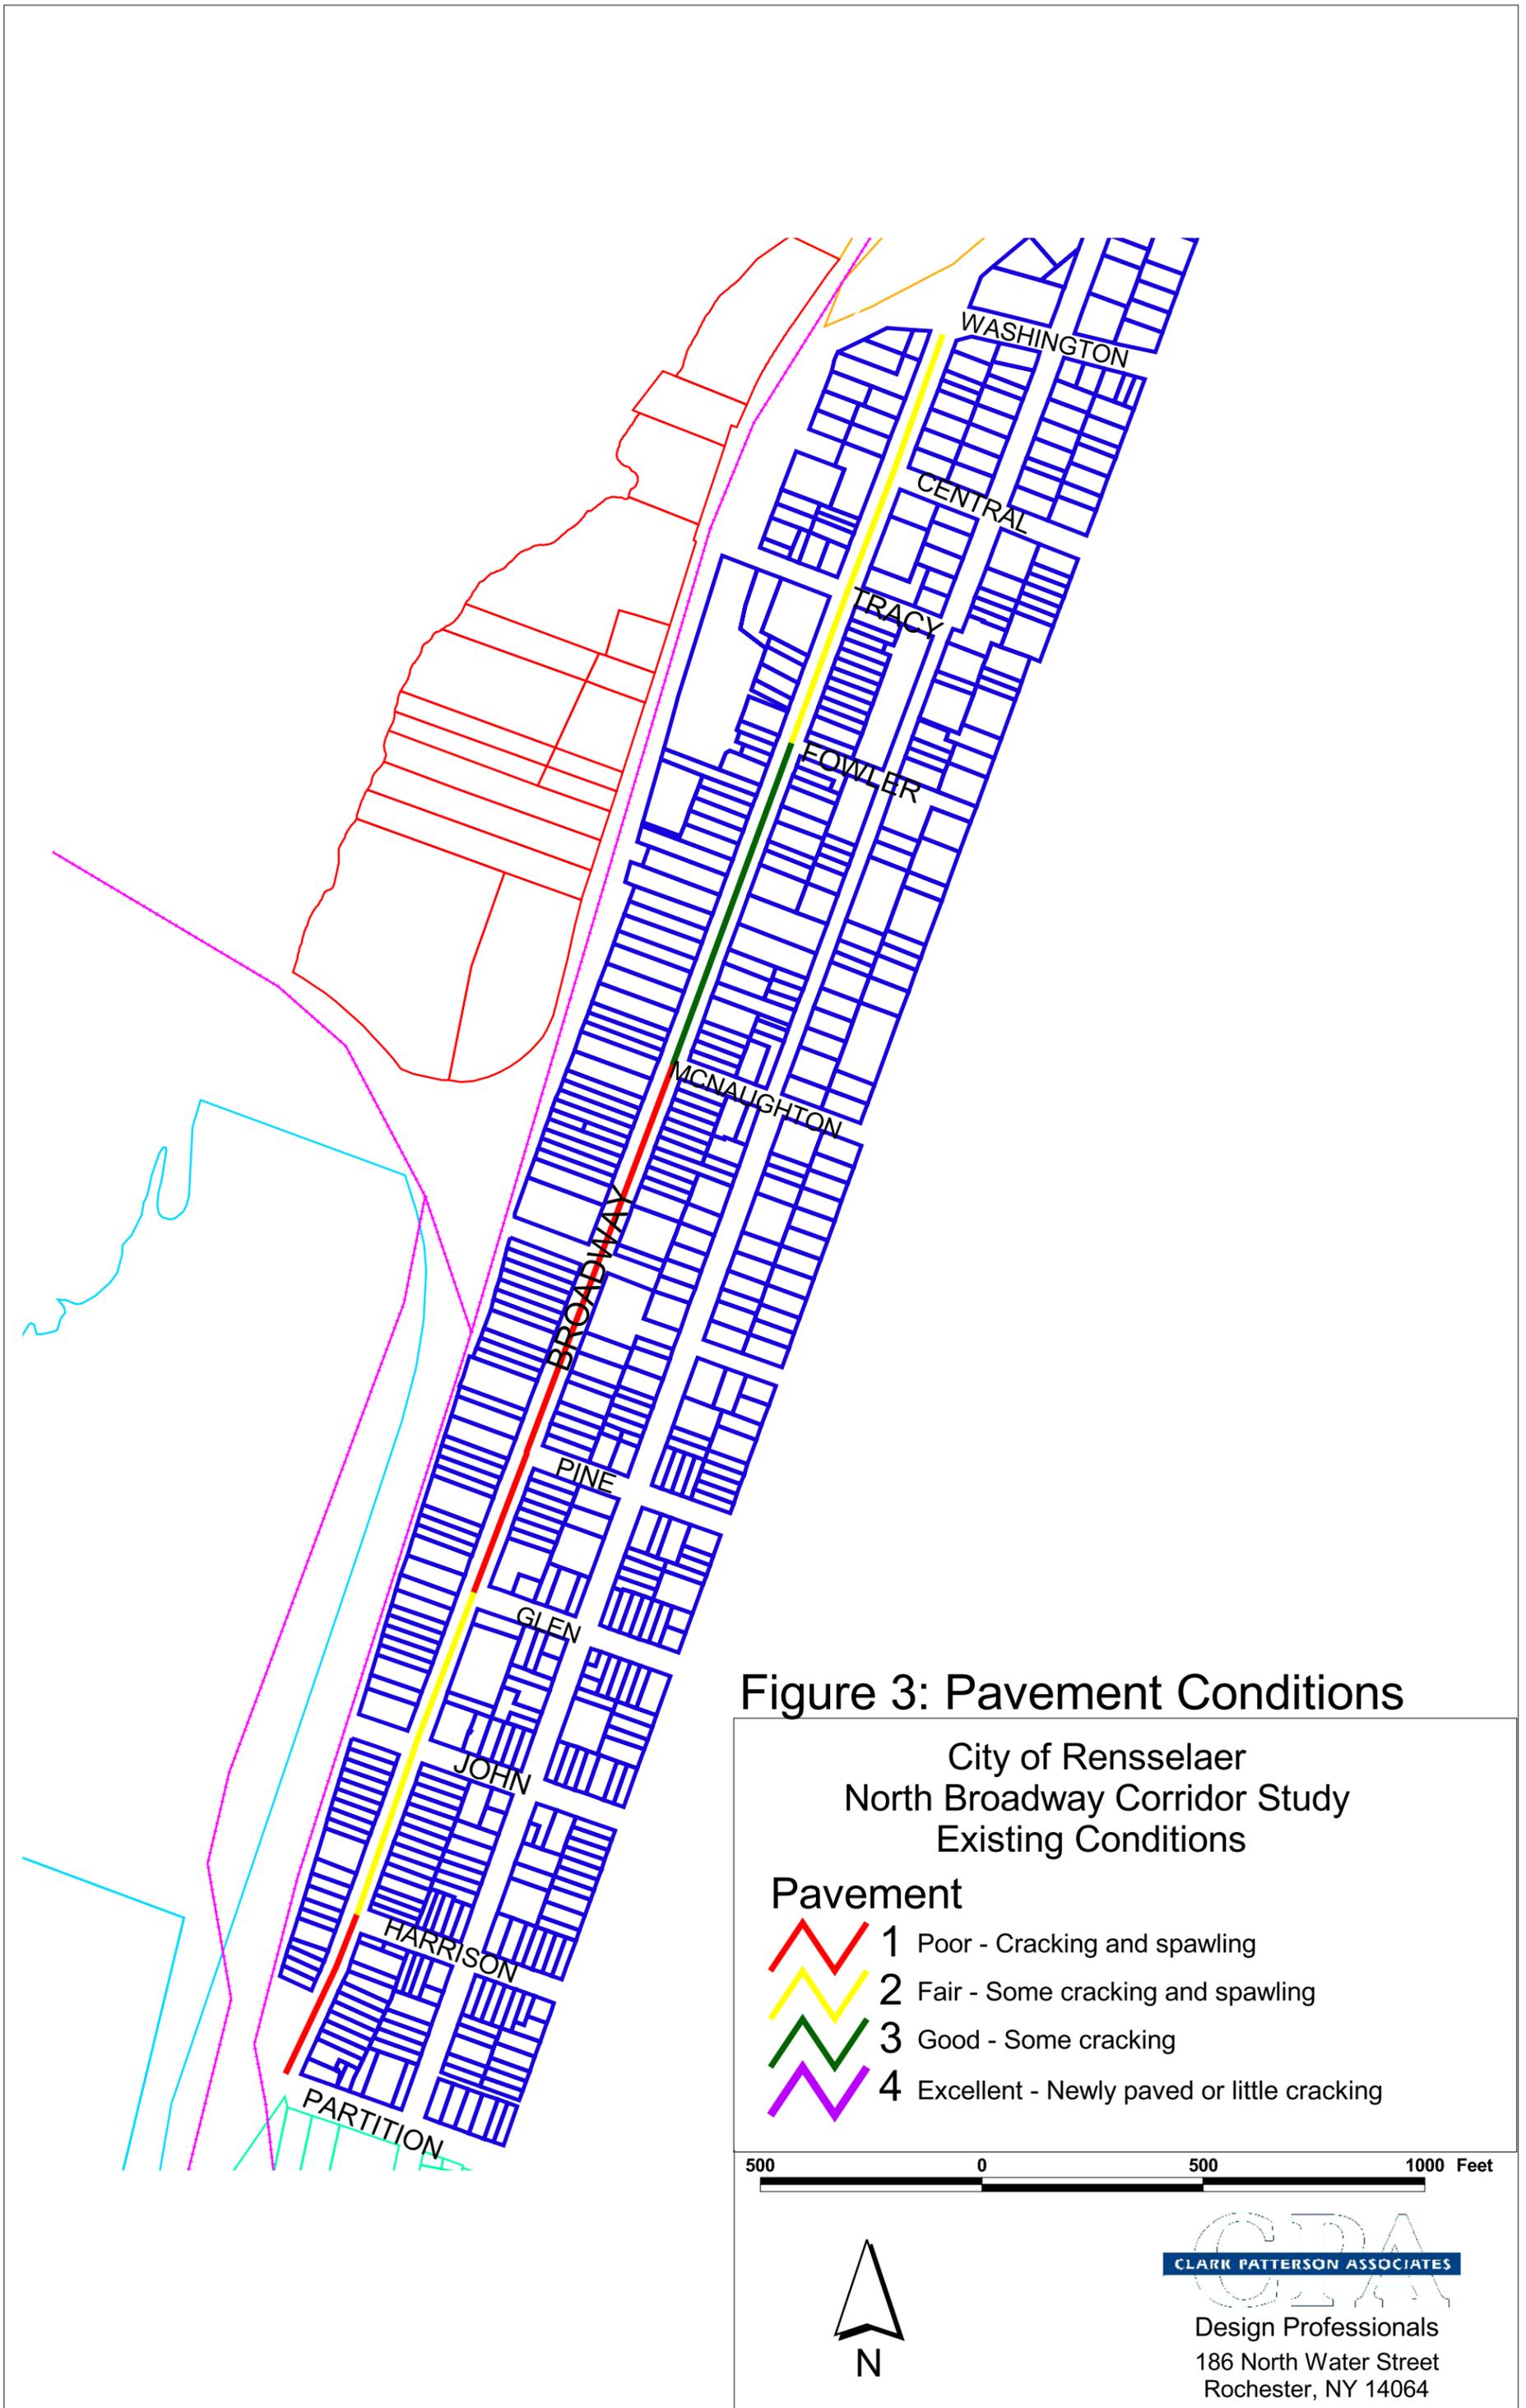
1 Poor - Cracking and spawling
-

2 Fair - Some cracking and spawling
-

3 Good - Some cracking
-

4 Excellent - Newly paved or little cracking

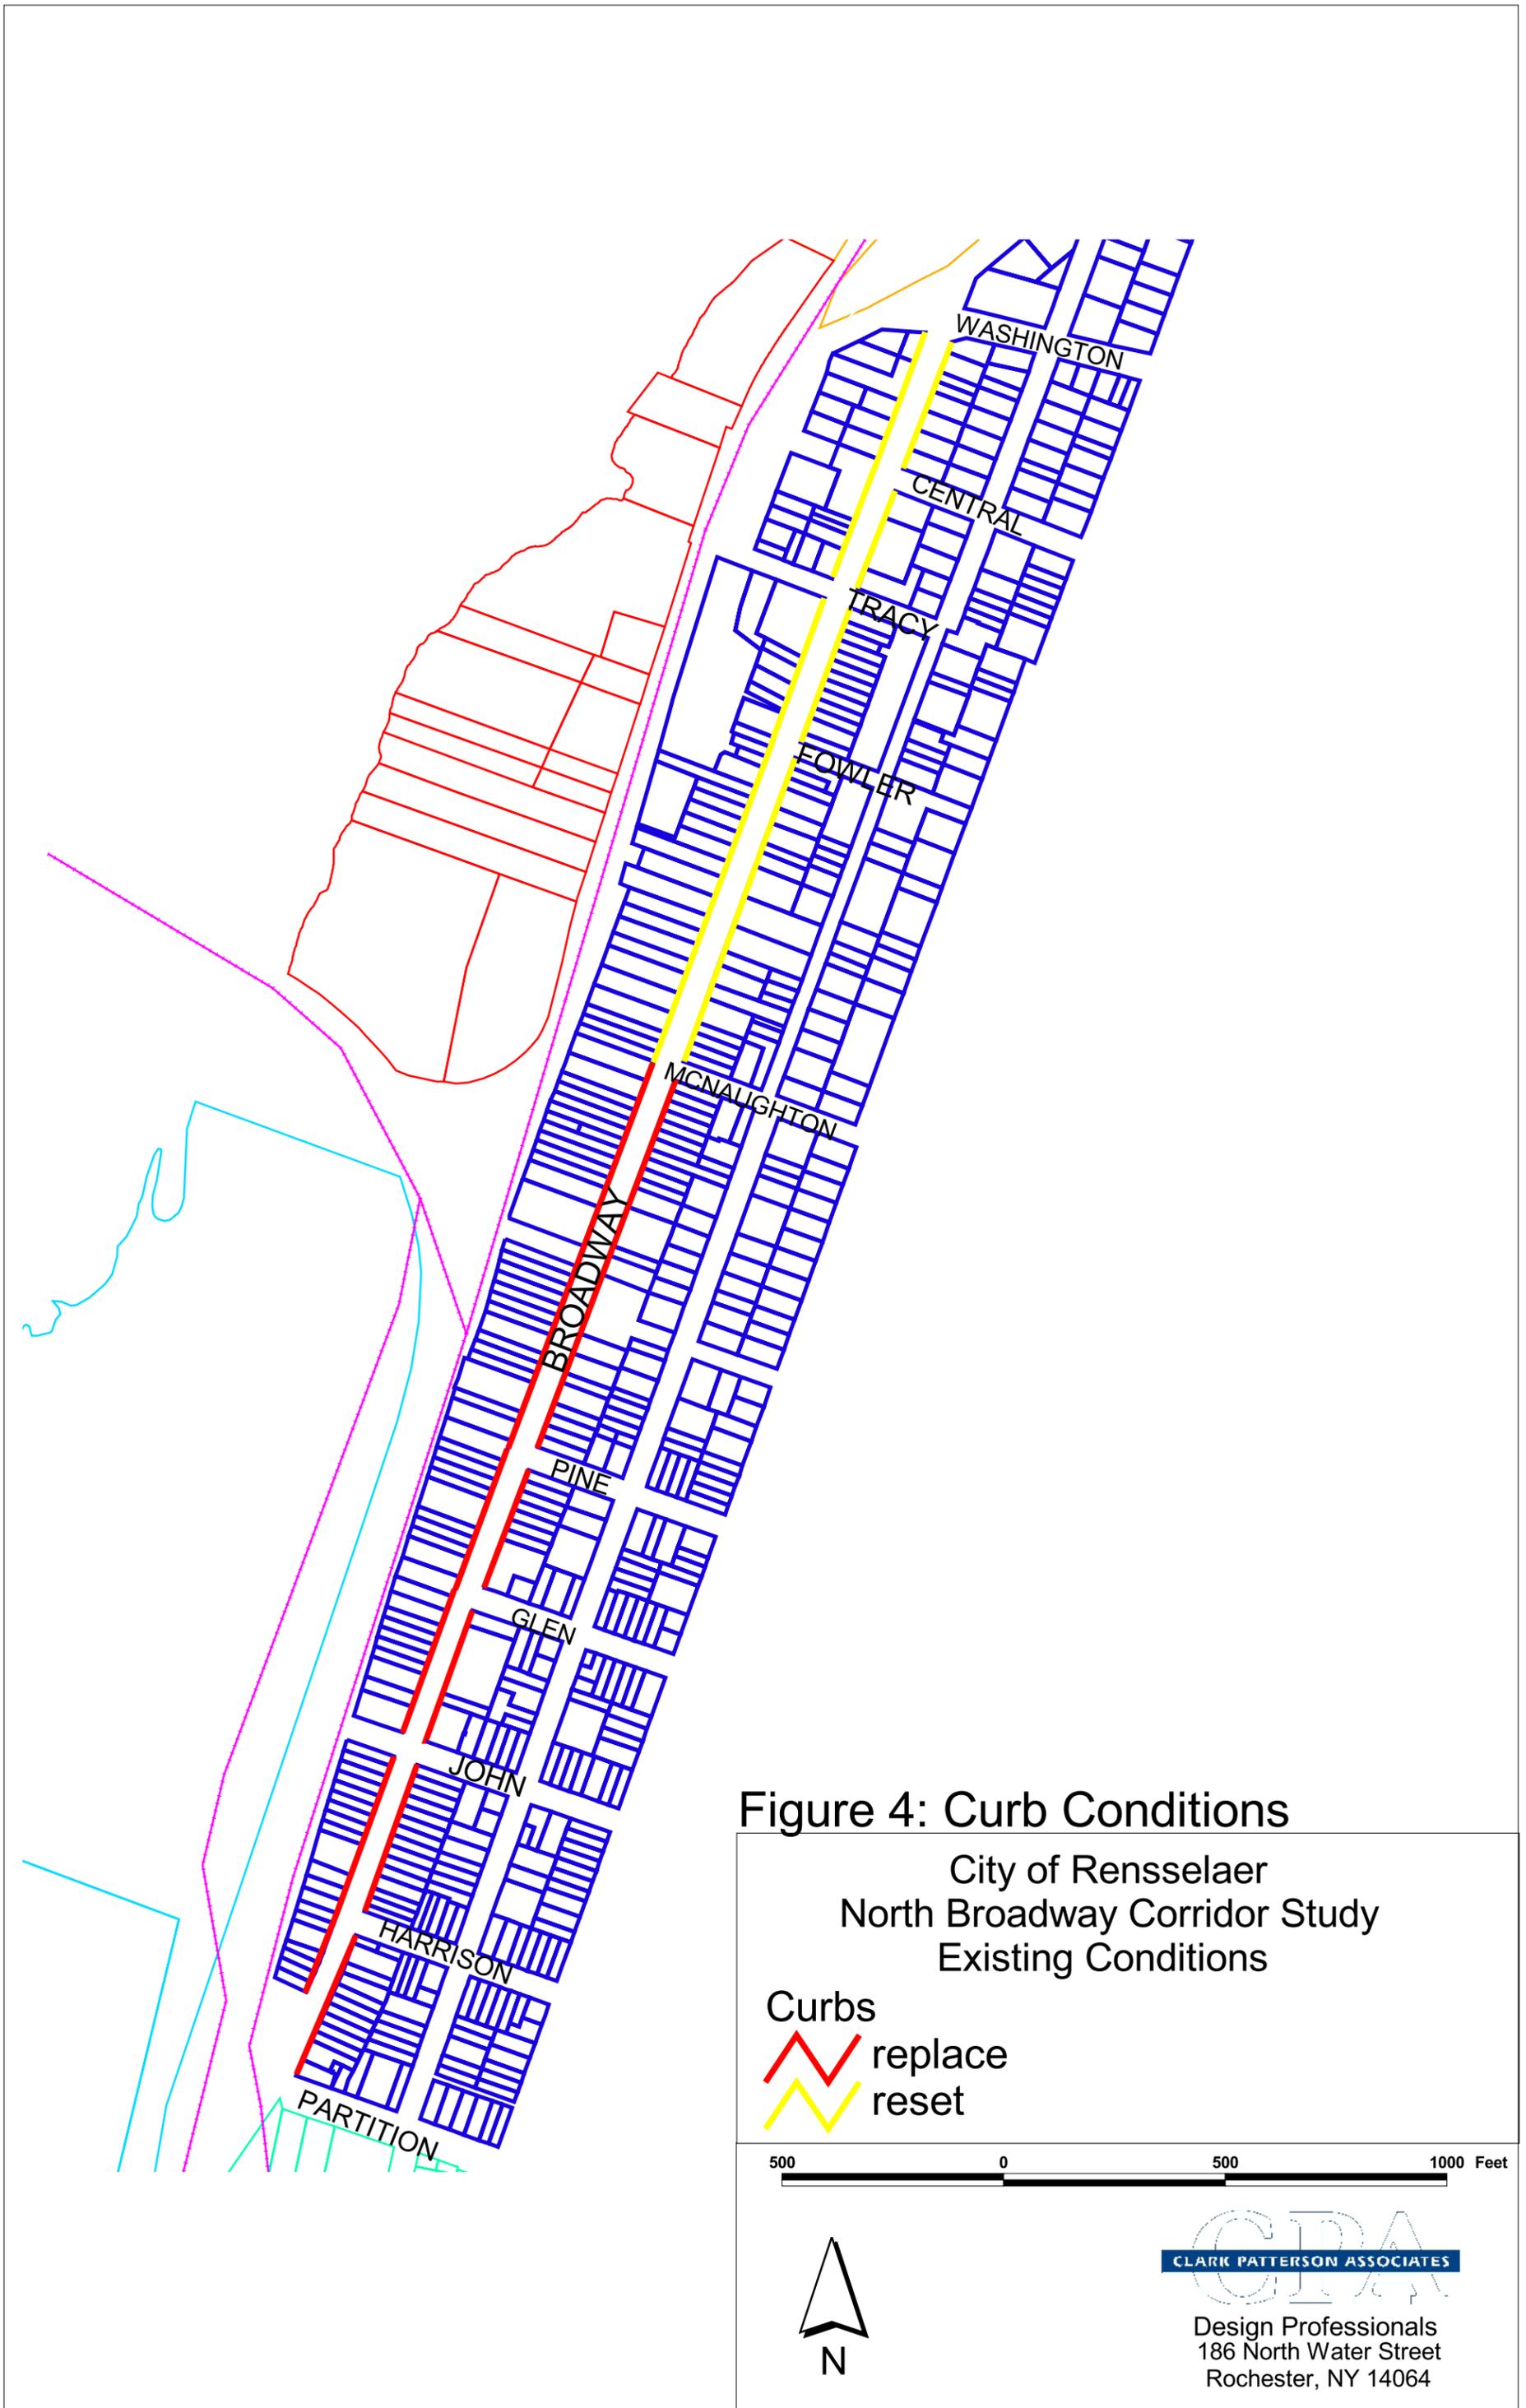
Figure 4: Curb Conditions

replace
 -

reset

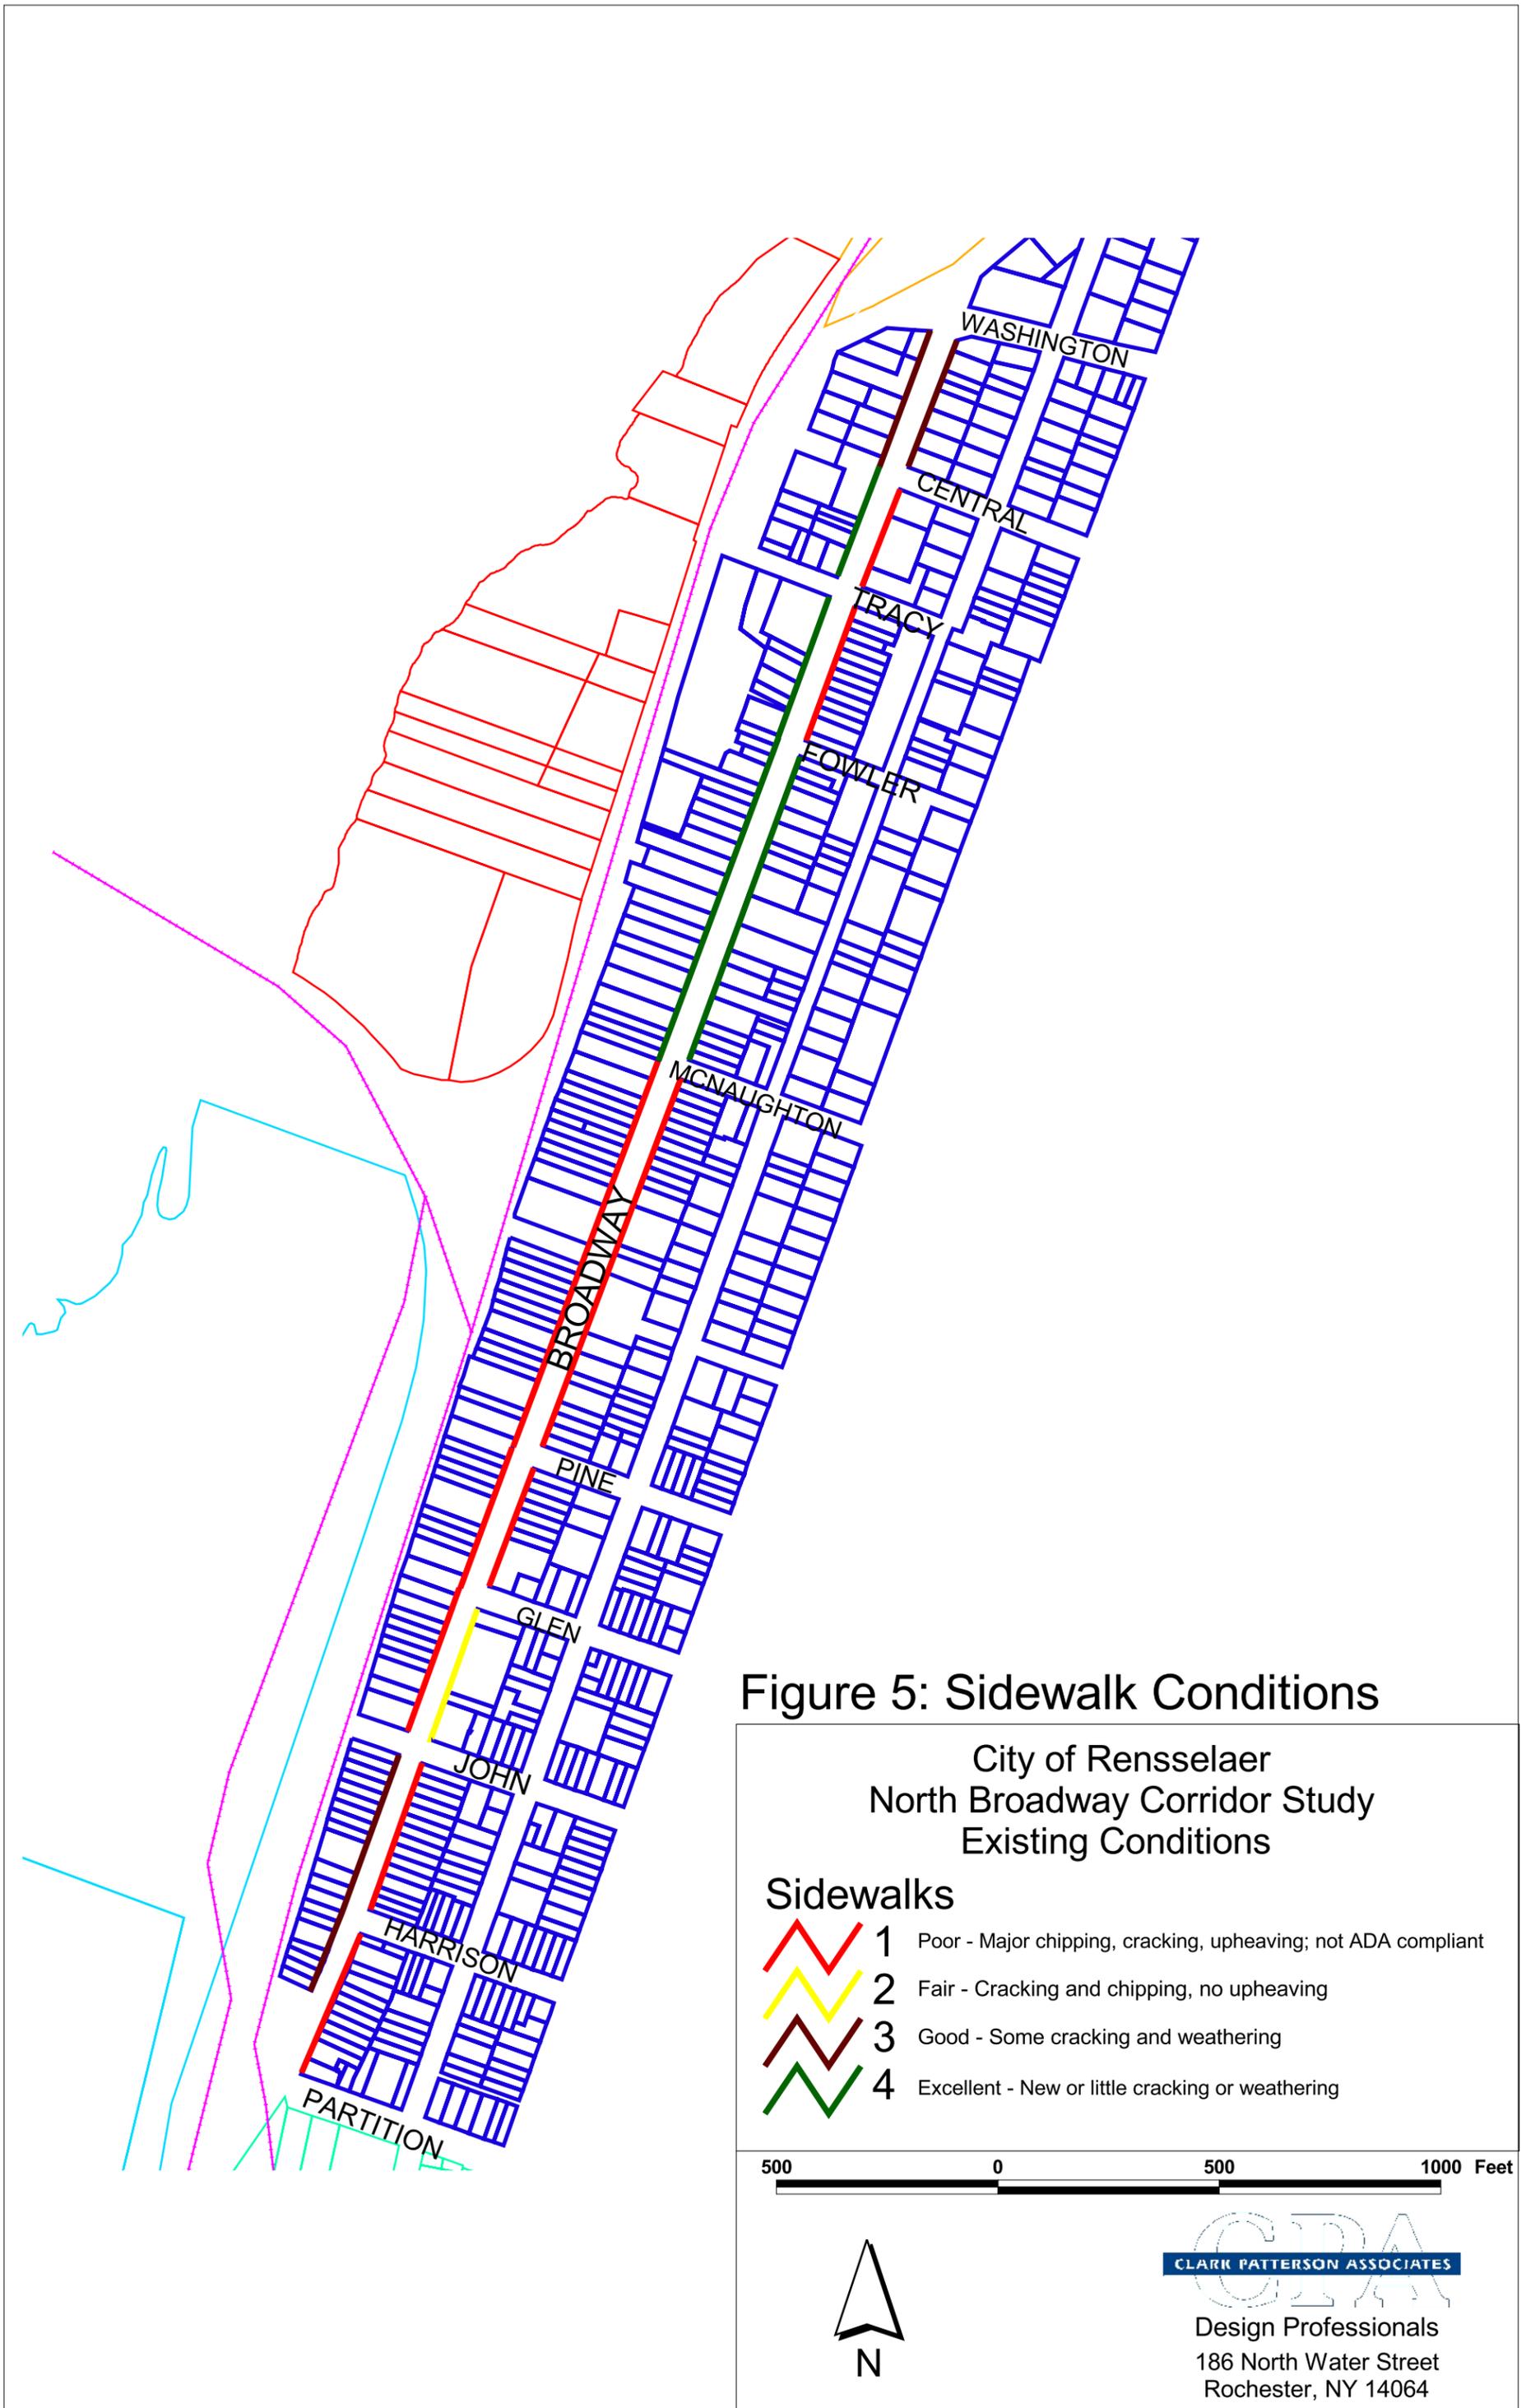
Figure 5: Sidewalk Conditions

1 Poor - Major chipping, cracking, upheaving; not ADA compliant
-

2 Fair - Cracking and chipping, no upheaving
-

3 Good - Some cracking and weathering
-

4 Excellent - New or little cracking or weathering

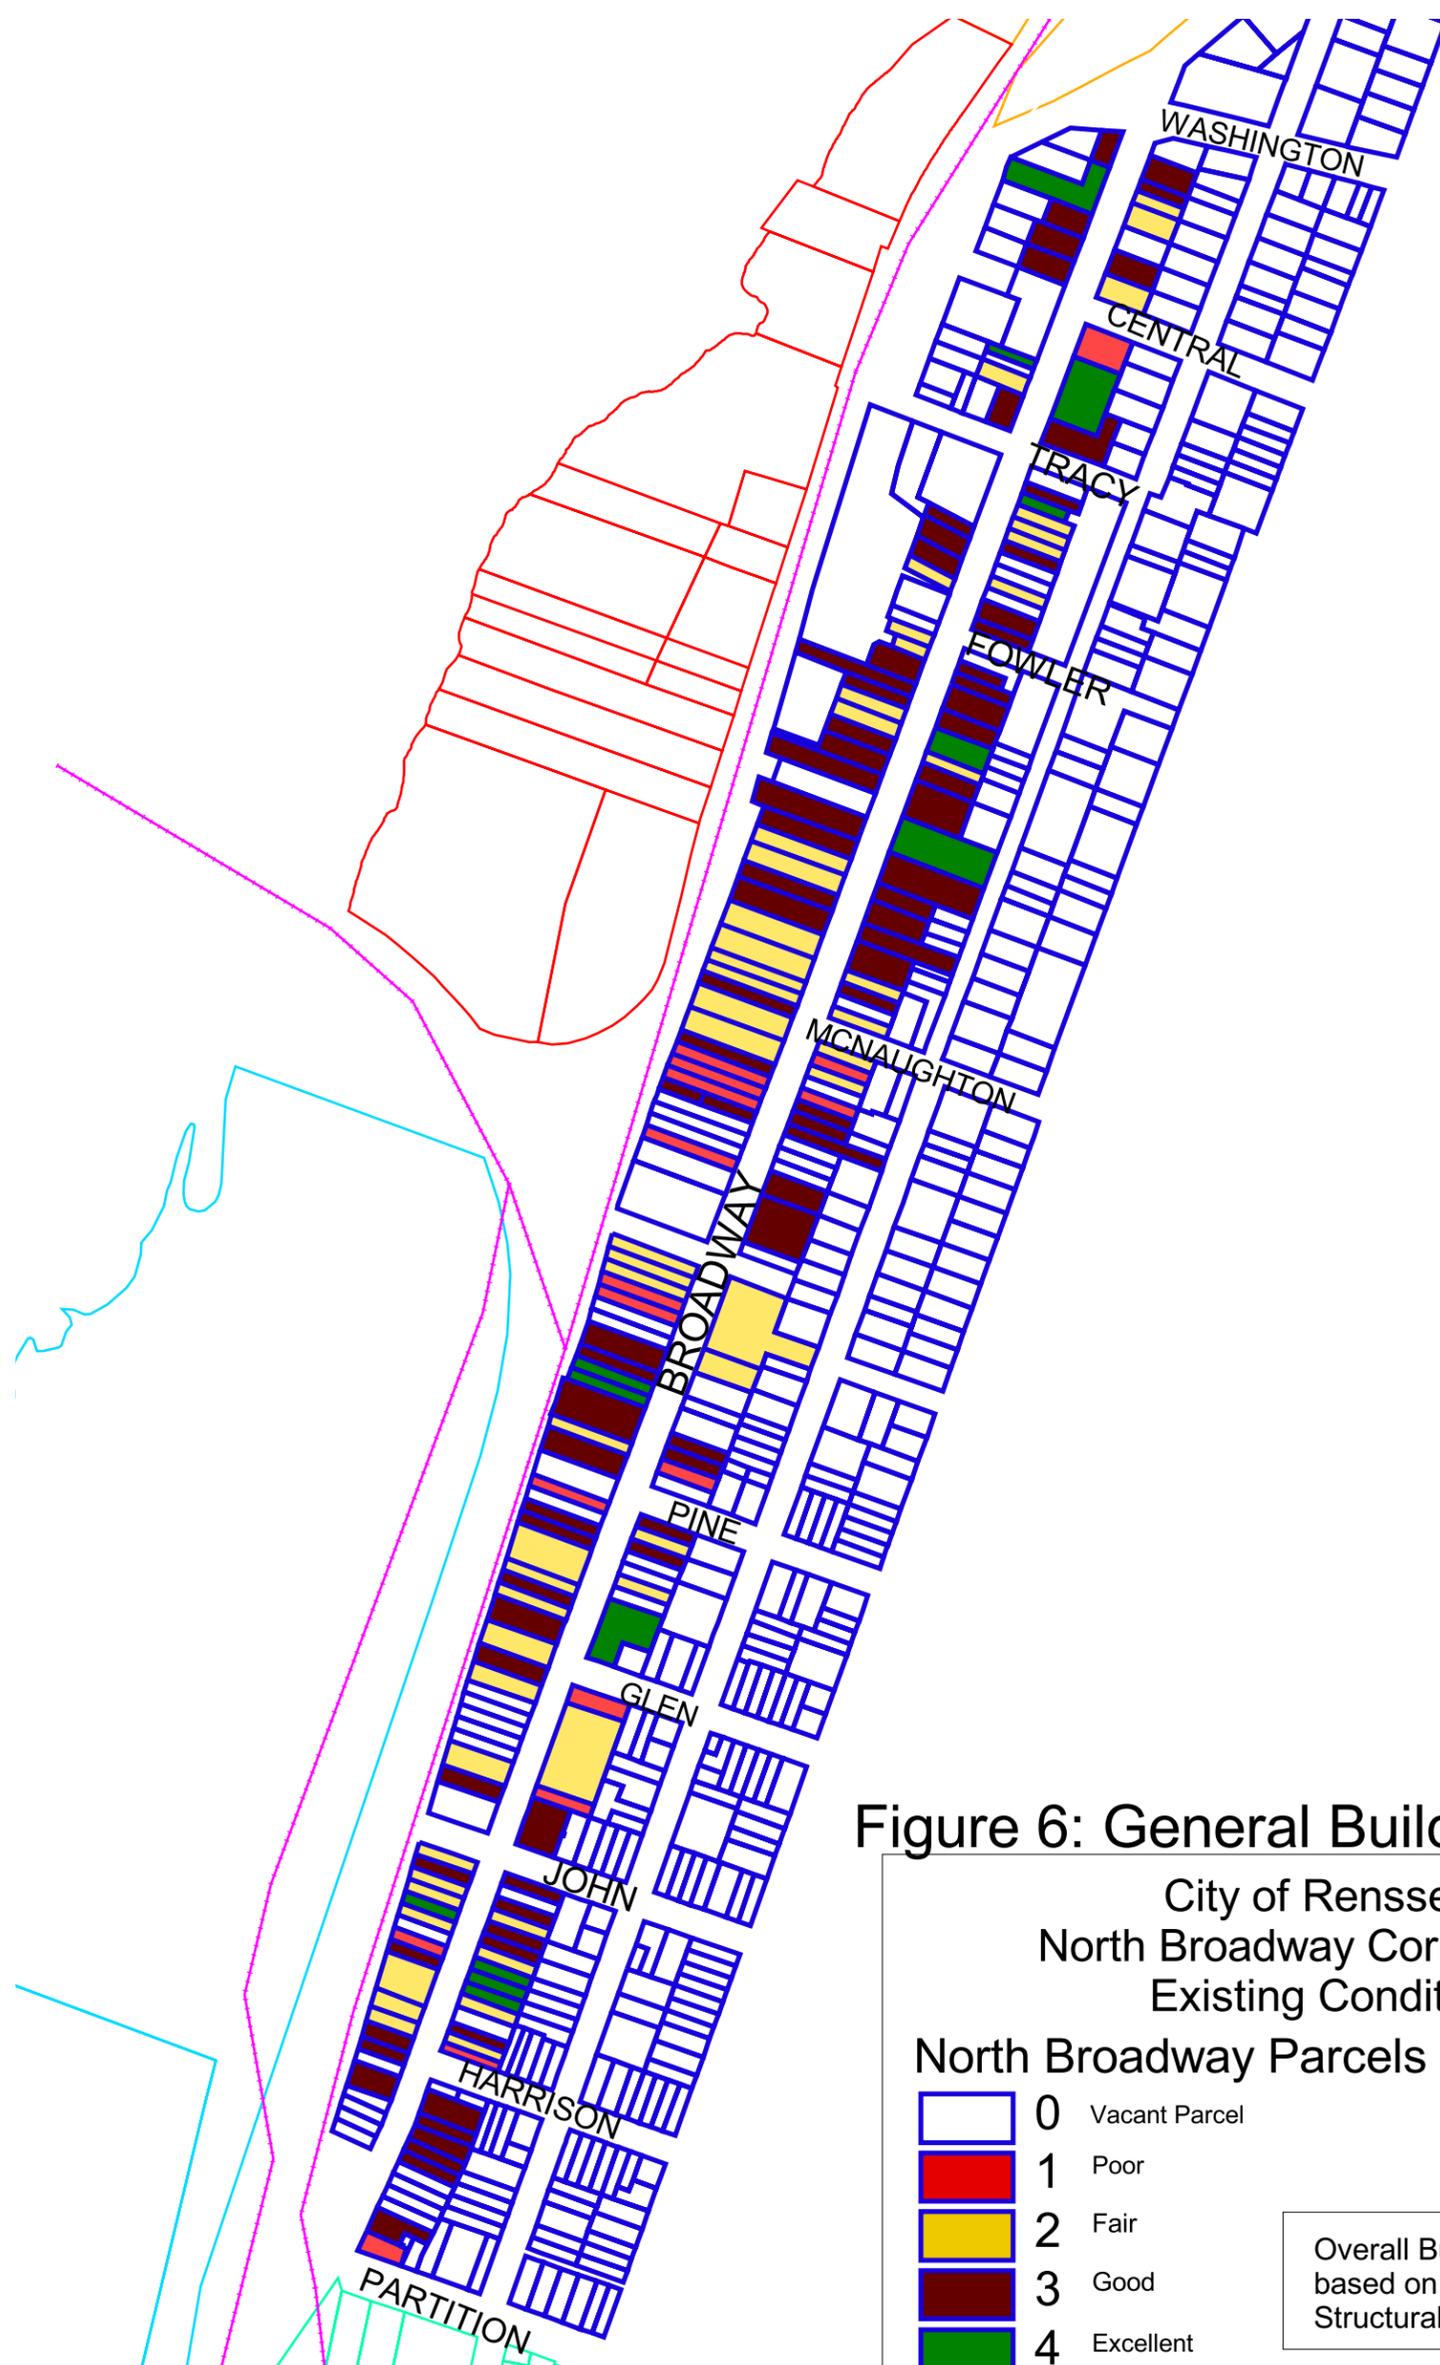
Figure 6: General Building Conditions

- 0 Vacant Parcel
- 1 Poor
- 2 Fair
- 3 Good
- 4 Excellent

Overall Building Conditions are based on the average of Facade, Structural, and Window analysis.

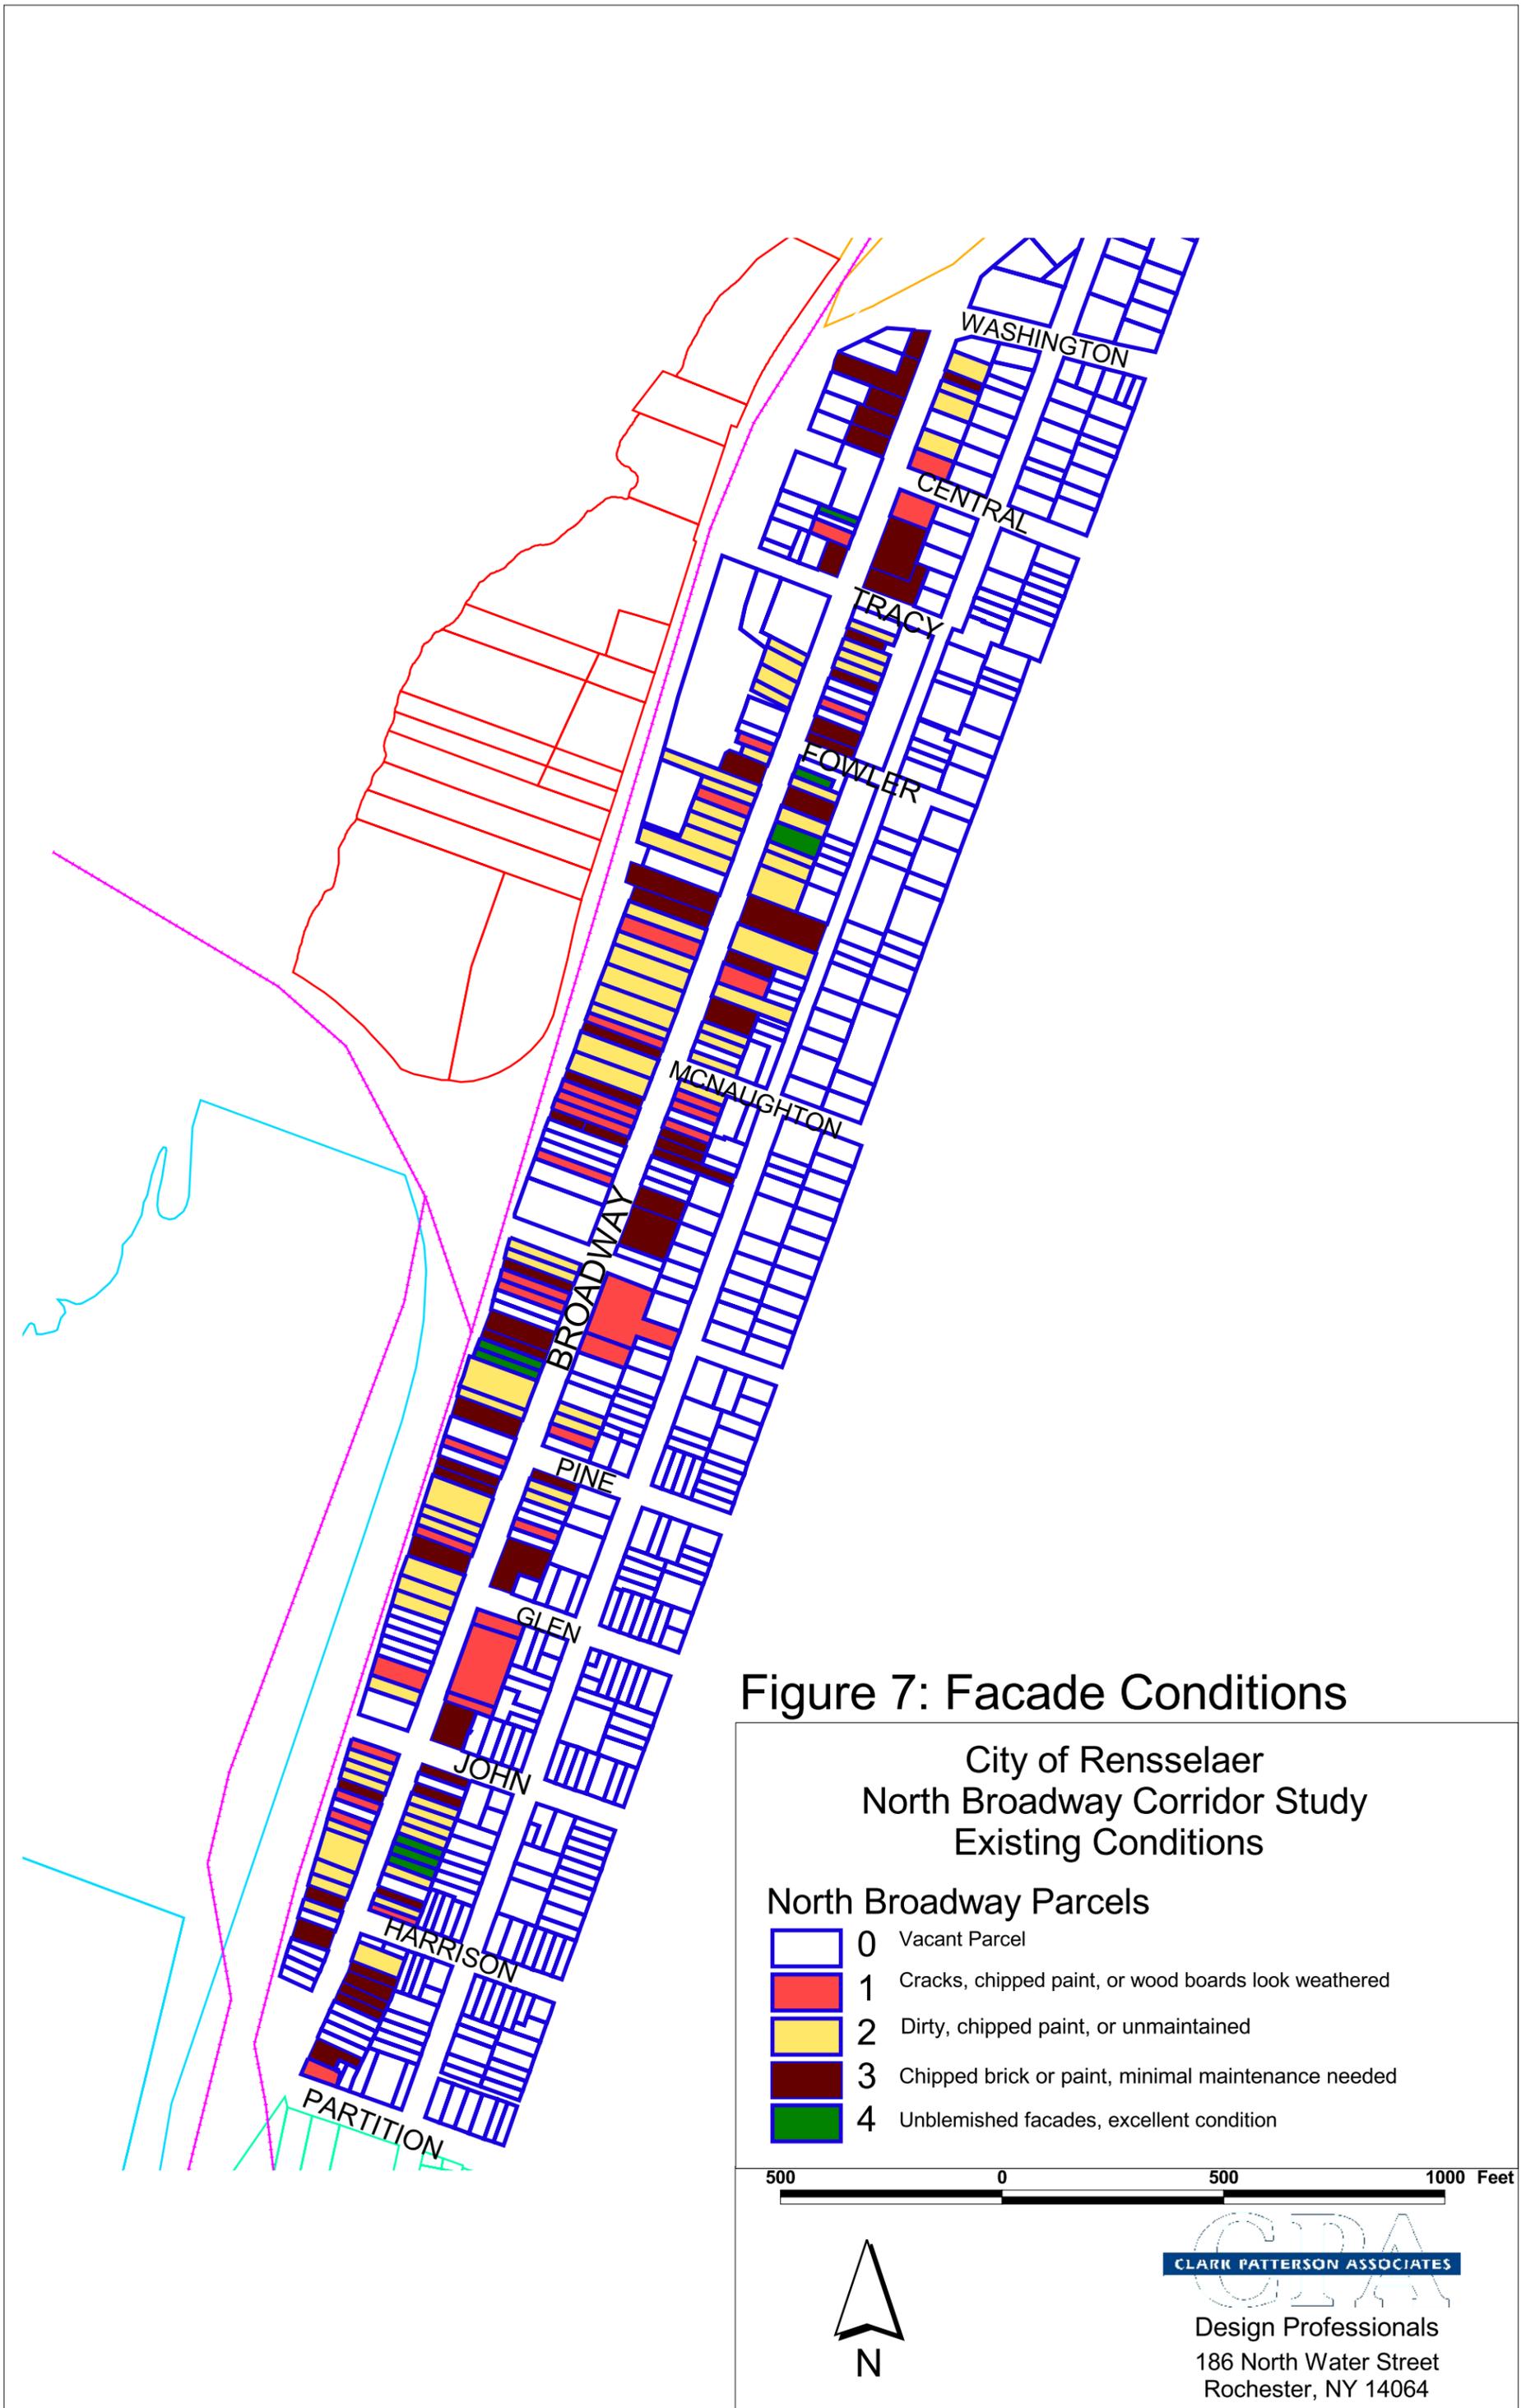
Figure 7: Facade Conditions

- 0 Vacant Parcel
- 1 Cracks, chipped paint, or wood boards look weathered
- 2 Dirty, chipped paint, or unmaintained
- 3 Chipped brick or paint, minimal maintenance needed
- 4 Unblemished facades, excellent condition

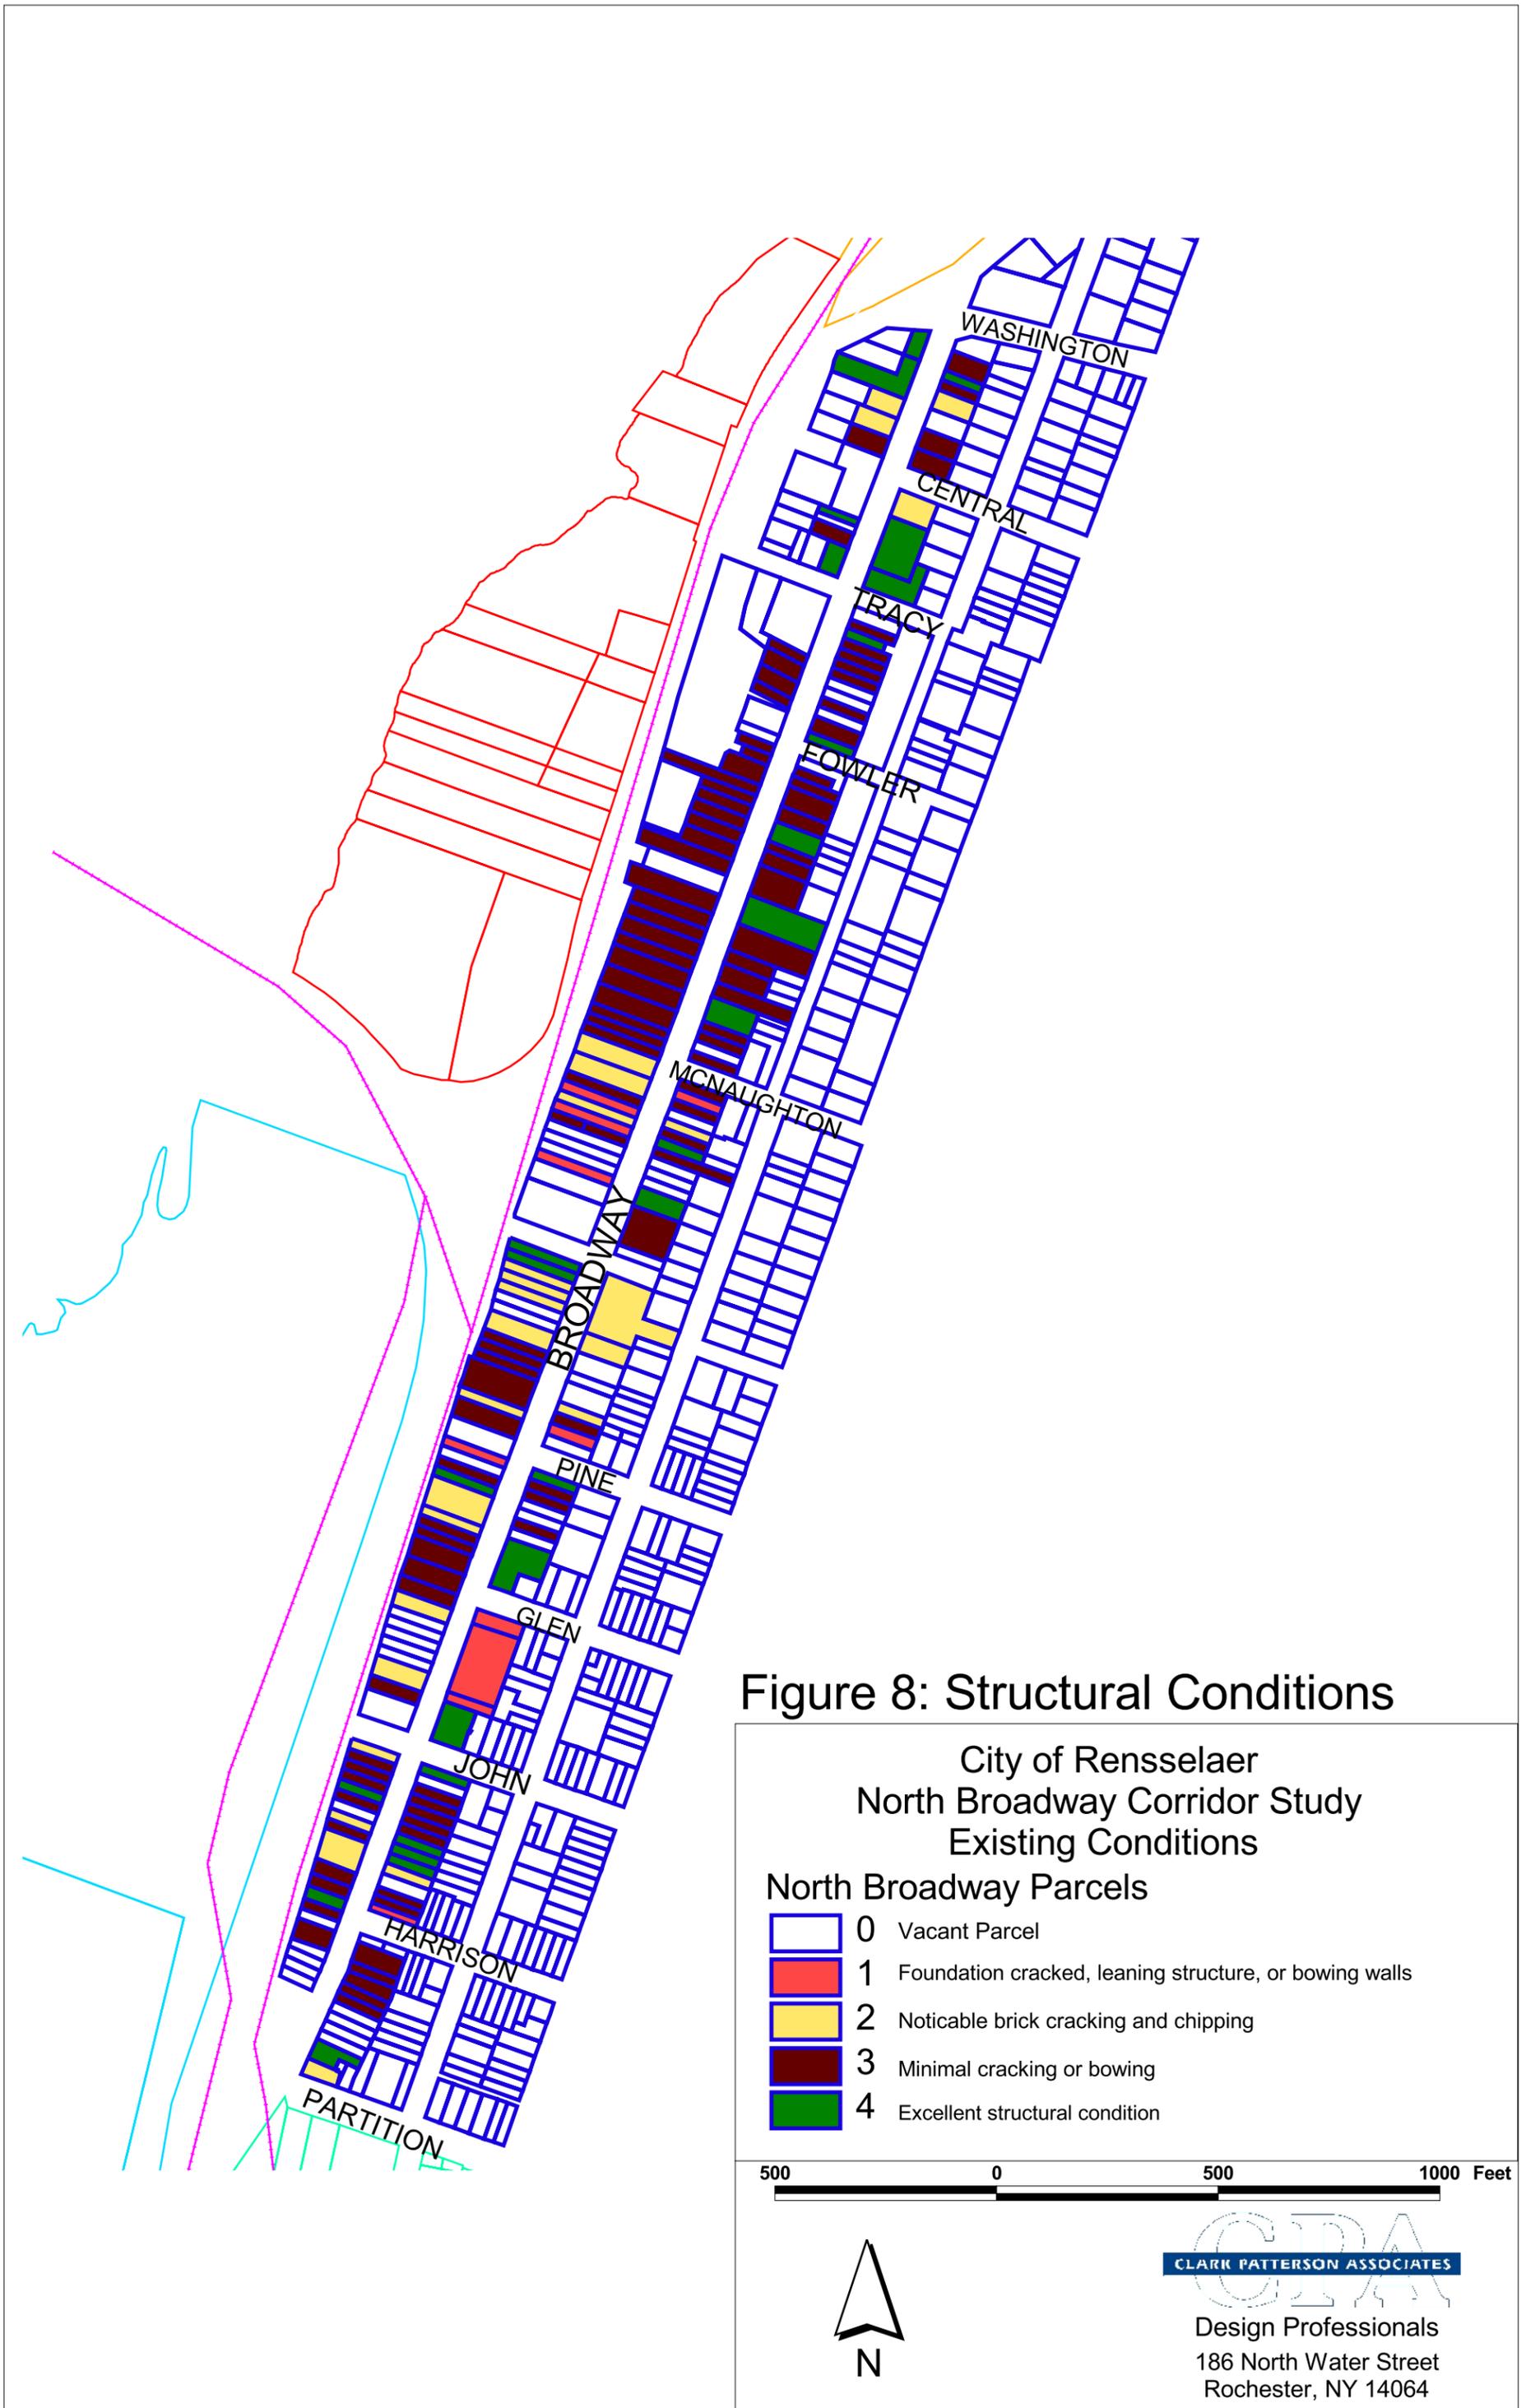
Figure 8: Structural Conditions

- 0 Vacant Parcel
- 1 Foundation cracked, leaning structure, or bowing walls
- 2 Noticable brick cracking and chipping
- 3 Minimal cracking or bowing
- 4 Excellent structural condition
